**The Elimination of
Body Leaks on the
VOLKSWAGEN 1500**

Group: A 25

Edition: September 1964

VOLKSWAGENWERK AKTIENGESELLSCHAFT

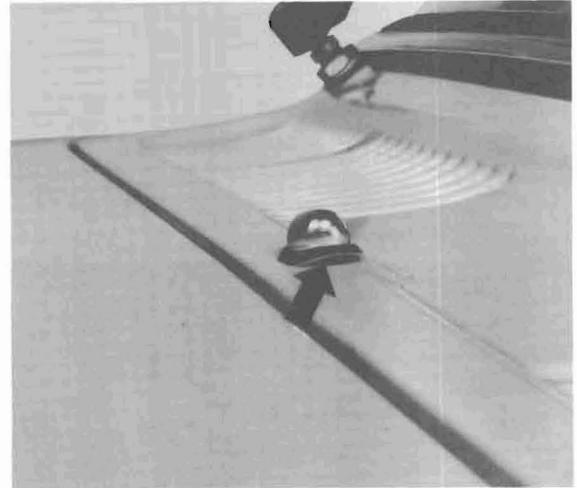
A I/1 - At the windshield washer jet. Either through the seal for the jet or at the jet itself which is mounted in plastic.

A coat of D 12 sealing compound under the seal or, if the jets are leaking, replace the jet mounting.

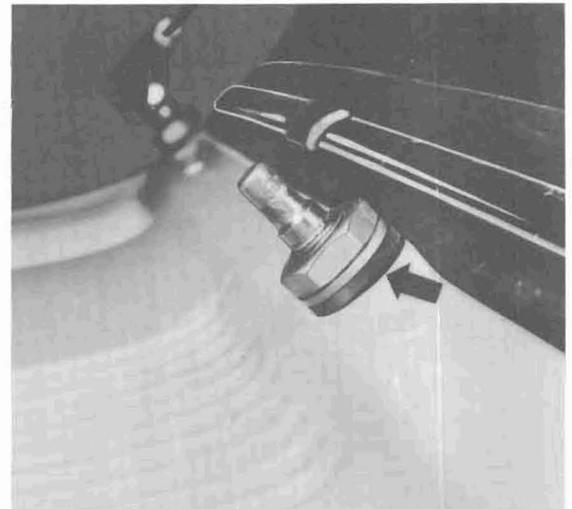
A I/2 - At the windshield wiper shaft bearing seal.

- a - Check if the nut is tight and the seal located properly.
- b - Use a larger washer (21.2 mm dia)
- c - If the wiper shaft shows signs of seizure, the operating linkage must be replaced.

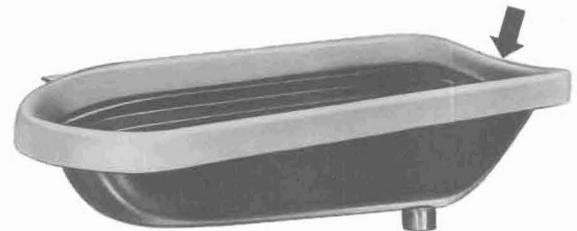
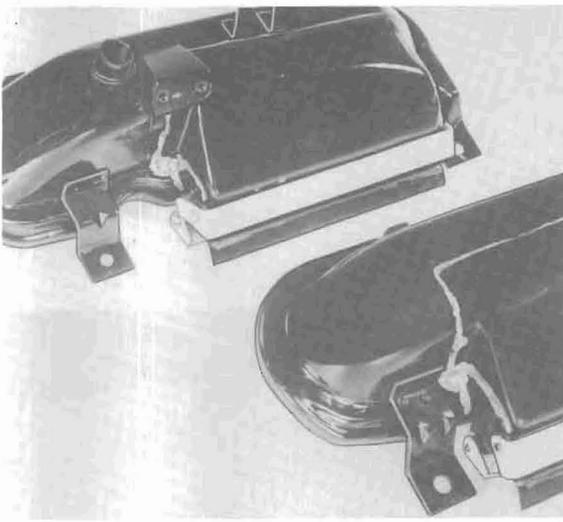
A I/3 - At the fresh air control box seals, particularly in the corners.

Ensure that the seals are fitted properly, particularly in the corners. If necessary, straighten the control box in the corners. Distorted seals must be replaced. If leaks still appear at the seal, it should be sealed with sealing compound.

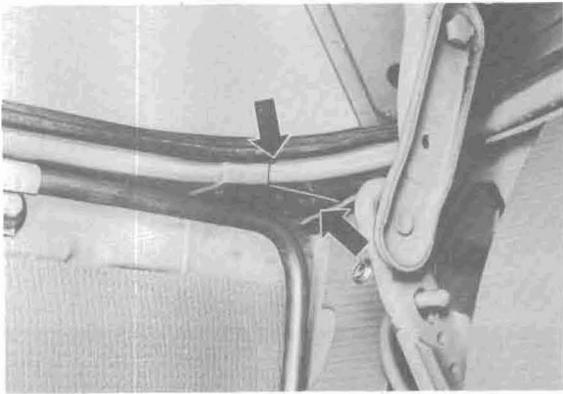
A II/1 - At the joint between roof, luggage compartment well and wheel housing - water runs over or under the hood weatherstrip behind the instrument panel. (Is also possible on vehicles on which the joint is brazed).

Cement weatherstrip on the curved part properly, ensure that hood makes good contact. The entire overlap should be coated with sealing compound on the inside.

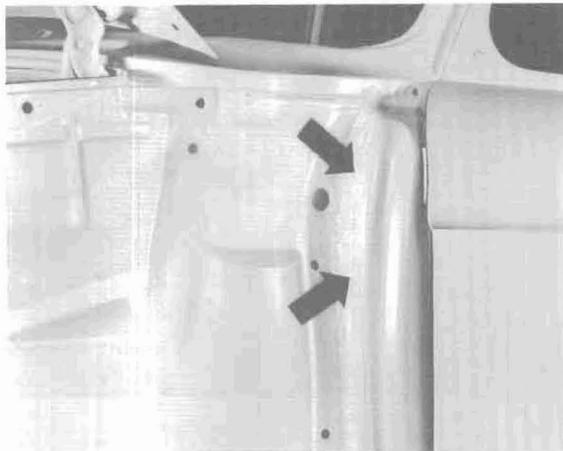
A II/2 - At the upper part of joint between wheel housing and side panel.

Take fender off and check that sealing compound has been applied properly. If necessary, coat the entire area with sealing compound.

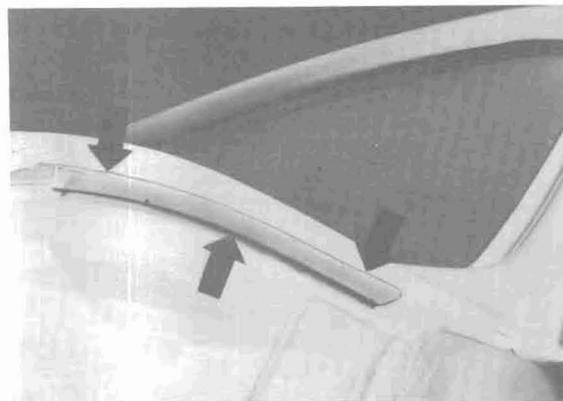
A II/3 - Soldered joint between cowl panel and side panel.

Take fender off and check for shrinkage holes in solder. If necessary, coat the soldered joint with sealing compound.

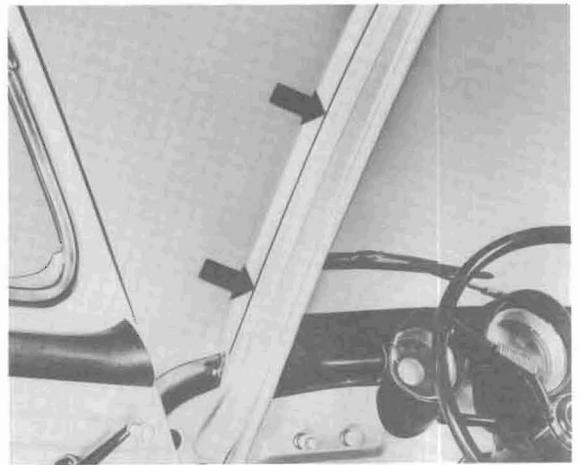
A II/4 - Under the roof channel

Coat the joint under the roof channel with D 20 jointing compound. Wipe surplus compound off with gasoline and paint joint to match vehicle color.

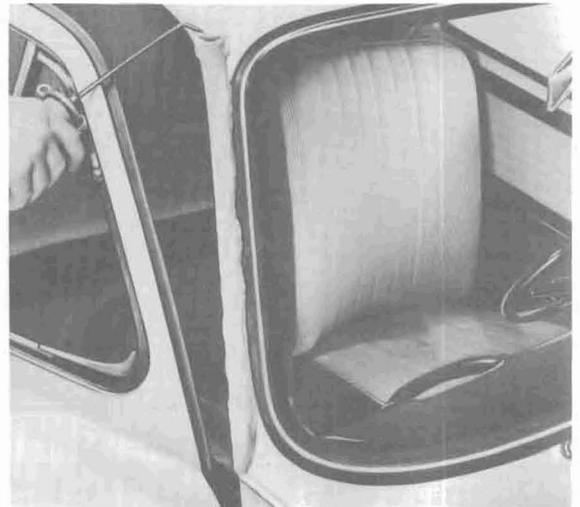
A II/5 - Under the flanged edge of the roof channel in the rain gutter.

Pack the gutter with plastic sealing compound so that the gutter can be filled with water. If the water level drops, coat the flanged edge with D 20 jointing cement.

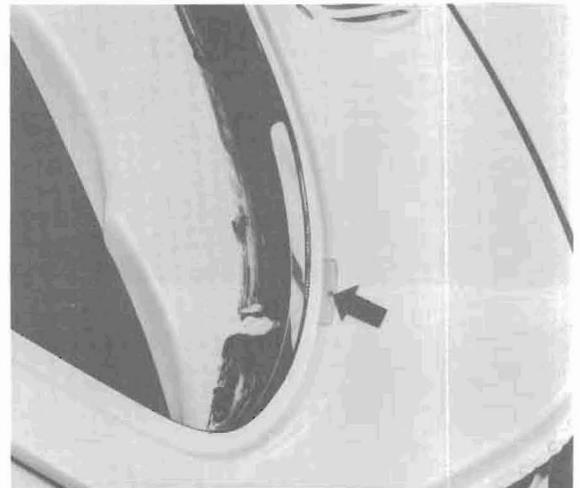
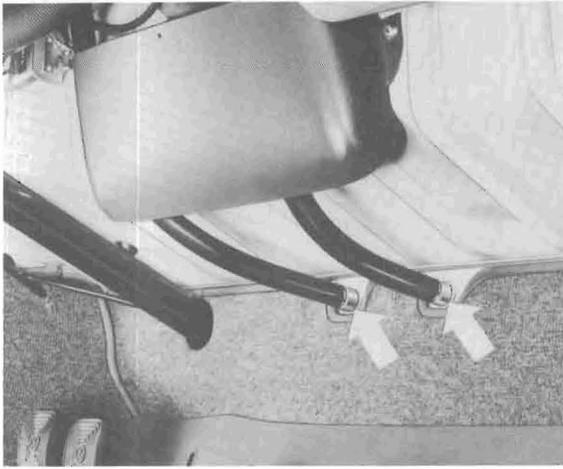
A II/6 - At the windshield seal.

Remove windshield. Any gaps between spot welds should be closed by pressing the sheet metal together and a coat of sealing compound applied. The paint drain holes should be closed with thin water-proof adhesive tape. Coat the windshield seal carefully with glycerine or talcum powder and insert windshield again.

A lasting seal cannot be obtained by just smearing sealer under the outside lip of the weatherstrip.

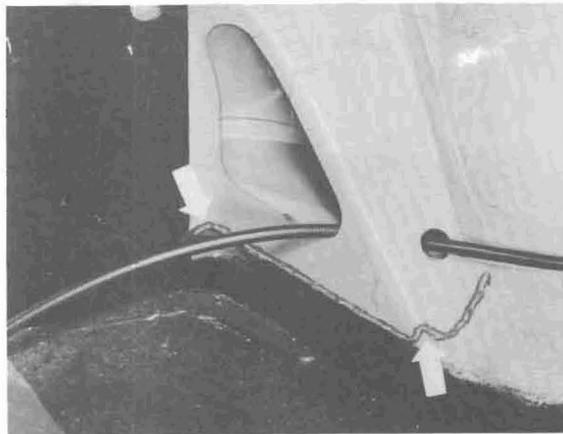
A III/2 - At the joint between front partition and wheel housing.

Coat the entire area, inside and out, with sealing compound. Check for burned through spot welds.

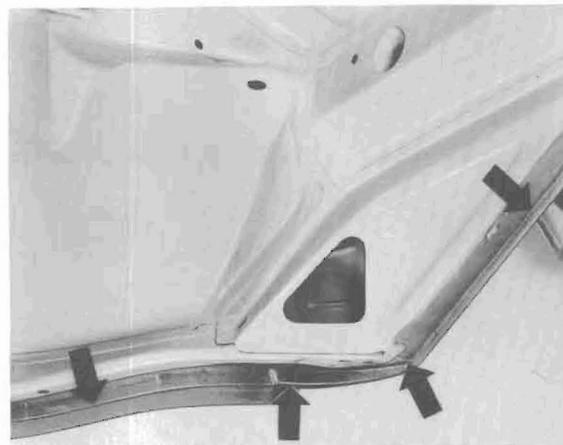
A III/3 - At the bottom of the front partition under the openings behind the foot rest.

Coat the seam near the two M 10 body bolts with sealing compound. If necessary, lift the body so that all areas are accessible.

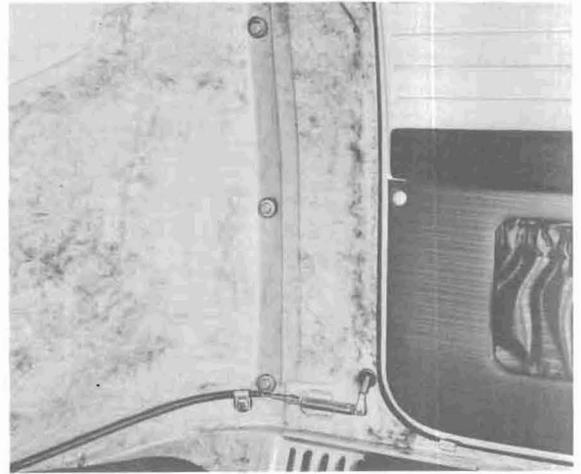
A III/4 - At the inner fender securing screws.

Check position of screws and rubber seals. Tighten screws if loose and replace seals if they have moved.

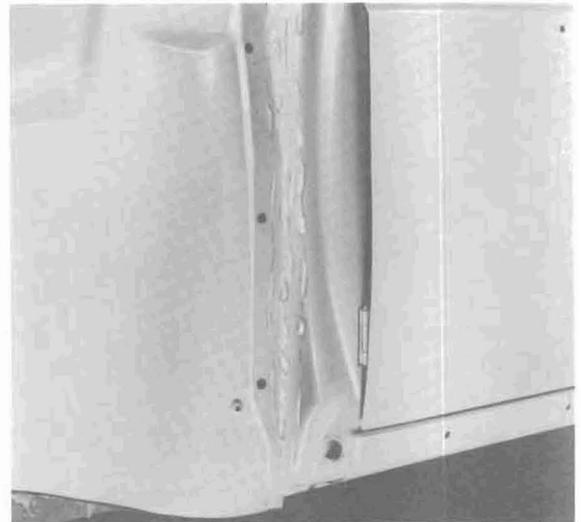
A III/5 - At the joint between wheel housing and side panel in center and lower areas.

Remove fender and check if sealing compound has been applied properly. If necessary re-seal the complete area with sealing compound. (see also point A II/2).

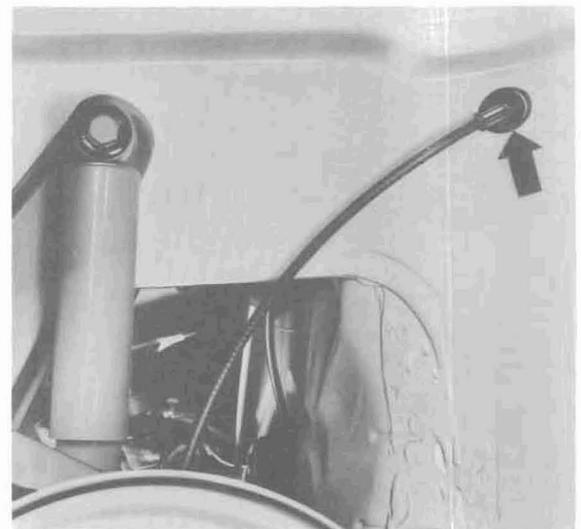
A III/6 - At the grommets for parking lamp and brake light switch cables and the seal for the speedometer drive cable in the side panel (illustration) and the lower rubber mounting for the steering column tube.

Ensure that the grommets are in good condition and properly located in body. If necessary, replace grommets or seal the holes with sealing compound.

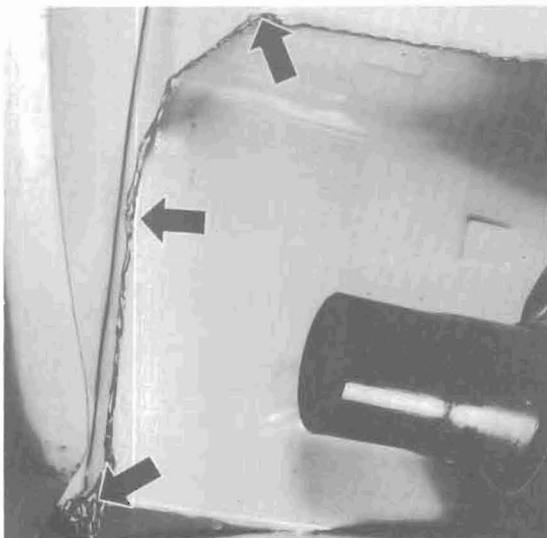
B 1 - Water runs out of the side members through the heater outlets into the vehicle interior.

- a - Check gas welded seam between wheel housing and quarter panel carefully and reweld as necessary.

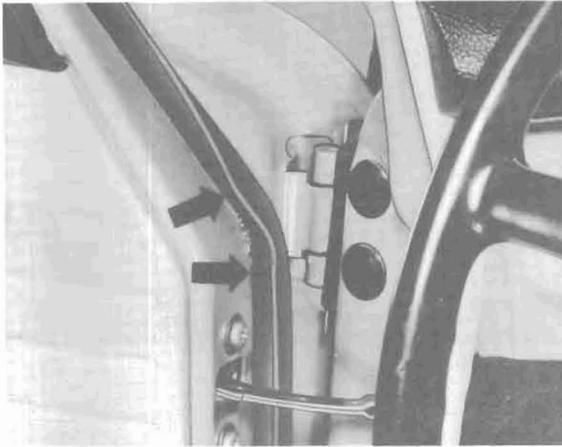
C 1 - At the door weatherstrip above the upper hinge.

Check door weatherstrip contact in door opening, if necessary, relocate weatherstrip. Ensure that the adhesive has dried before closing the door.

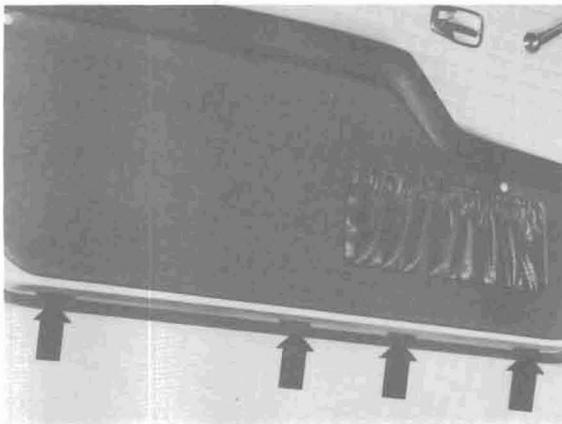
C 2 - At the bottom of the door weatherstrip.

Check position of door weatherstrip, particularly at the wider part. If necessary, relocate weatherstrip and allow adhesive to set before closing door.

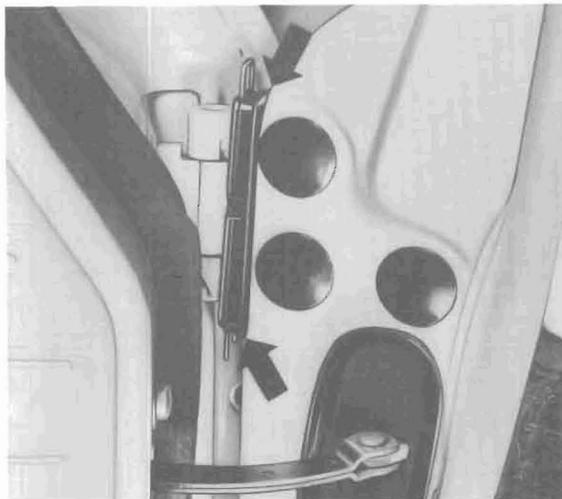
C 3 - At the hinge seals.

Ensure that the sealing rubber contacts properly. If necessary, stick the seal to the hinge pillar.

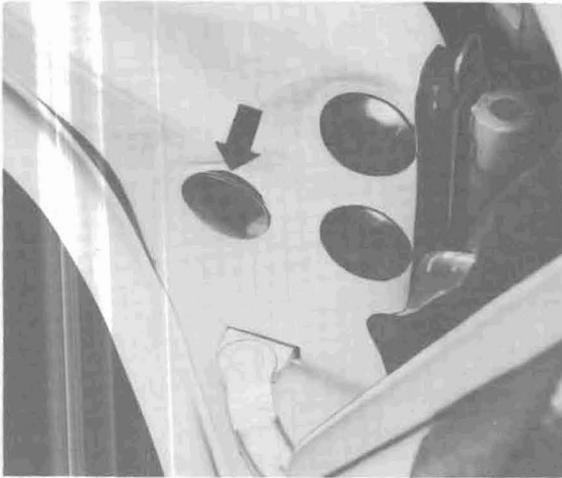
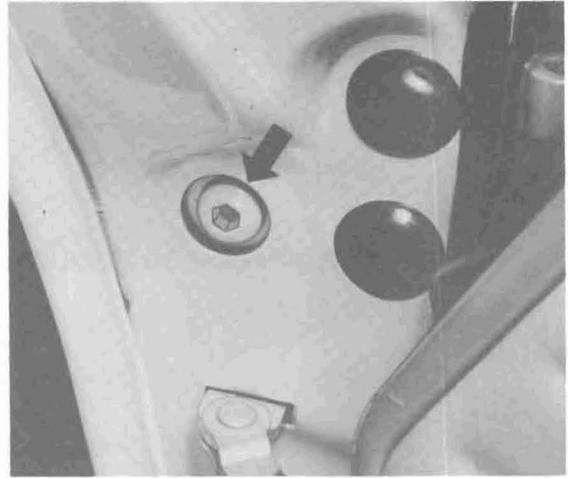
C 4 - At the caps for the hinge screws.

Install new caps. If necessary, grind the hinge screw heads down slightly so that the caps fit properly.

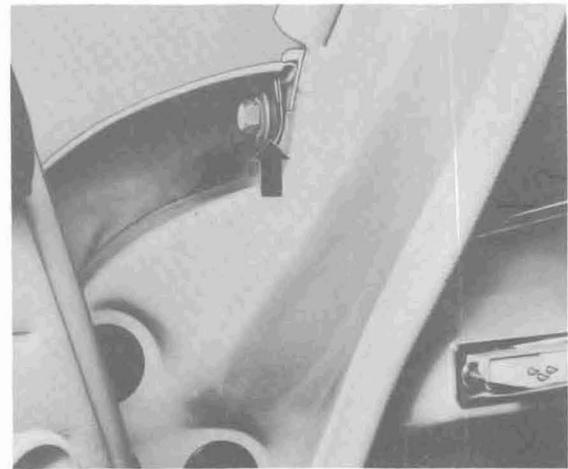
C 5 - At the upper outer fender securing screw (rubber washer displaced).

Crushed washers must be replaced and the entire area coated with sealing compound. To do this, the screw must be removed and the fender pressed away slightly. The washer shown must be between fender and body.

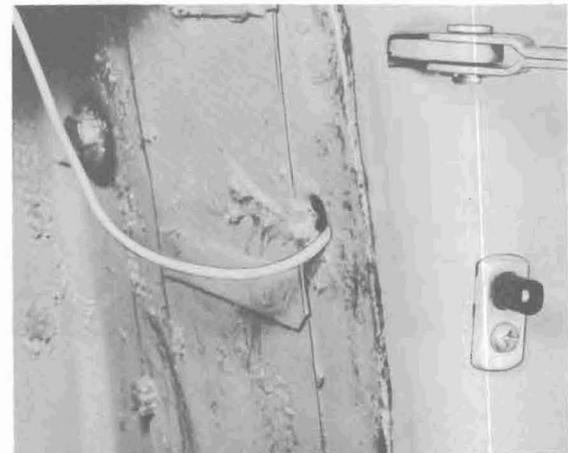
C 6 - At the hole for the interior lamp cable.

Cover hole with plastic sealer.

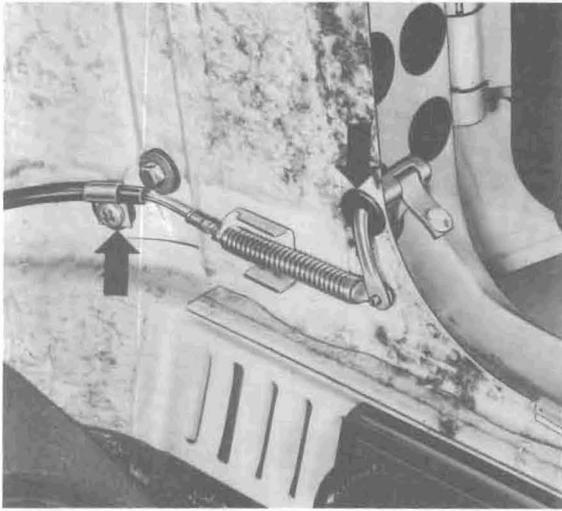
C 7 - At the hole for the backrest locking lever.

Close the hole by sticking a rubber washer (311 821 185) over it.

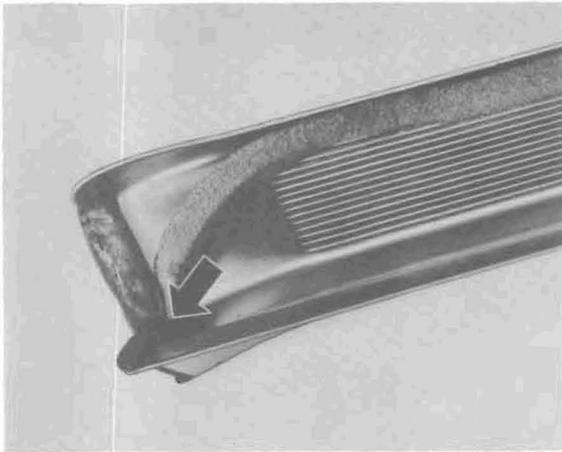
C 8 - Under the sill panel cover at front and rear, mainly at joint between plastic foam strip and door beading.

a - Remove sill panel cover and check plastic foam strip. Replace strip if necessary. Then seal sill panel cover with plastic sealer and install again.

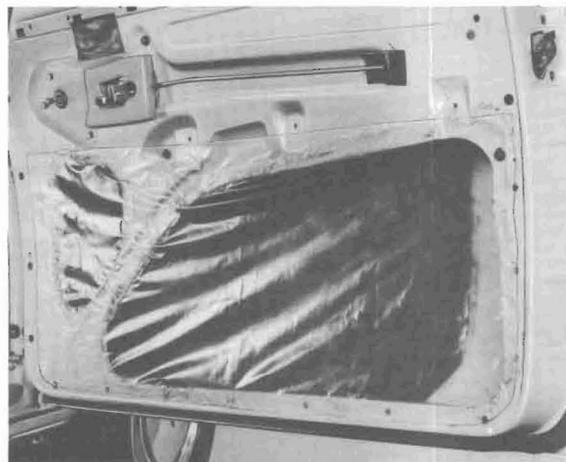
C 9 - Between the door inner panel and the oiled paper or plastic sheeting stuck to it.

Remove the oiled paper in every case and stick the plastic sheeting (311 867 145 A) to the door inner panel, using only D 12 universal adhesive. Damaged or loose plastic sheeting should be replaced.

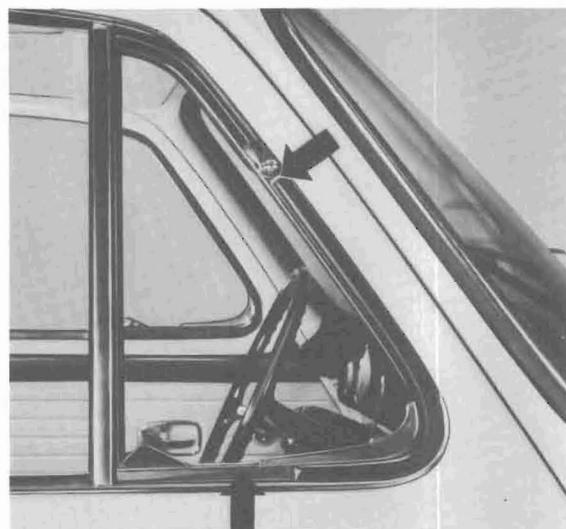
C 10 - At the seals for the vent wings.

Check location of seals. If necessary, remove vent wing and coat new seal with glycerine before installing. Replace fasteners if bent.

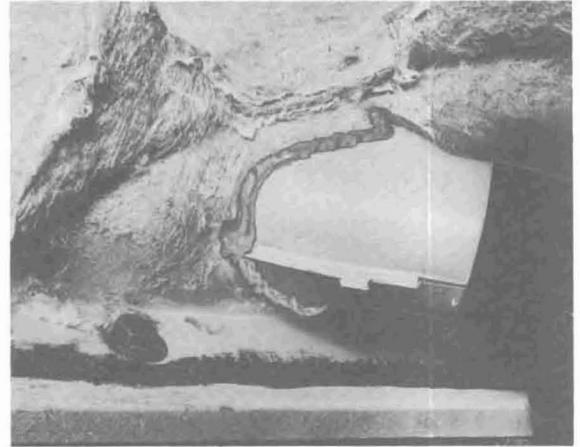
D 5 - At the welded or flanged seam where warm air pipe passes through luggage compartment floor.

Seal the hole round the warm air pipe with sealing compound.

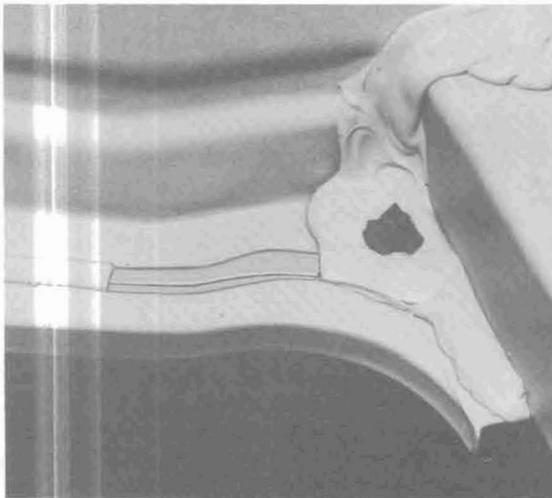
D 6 - At the joints on the rear luggage compartment floor. (Sealer is not located exactly on the joints).

a - Check joints at lowest point of floor inside and out and renew sealing compound where necessary.

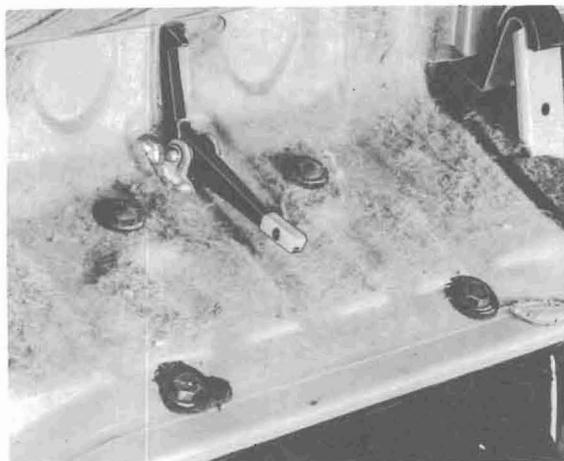
- D 7 - At the sealing rings for belt mounting on luggage compartment floor.

Check location of rings. If necessary, fit new rings and tighten plugs.

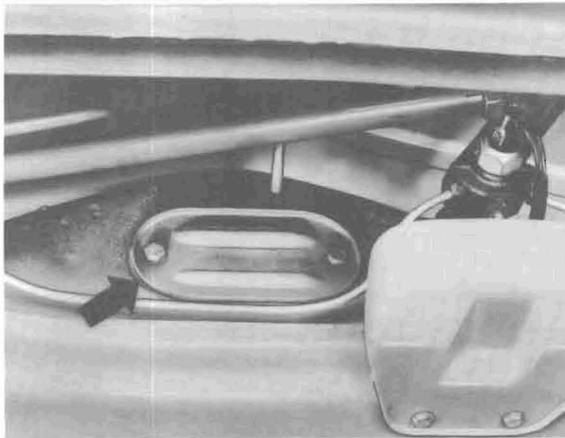
E 2 - At the joint between frame tunnel and floor plates.

a - Check spot welding. Burned spot welds should be gas welded from outside and sealed with sealing compound from inside.
