BODY LEAKS • VW SEDAN

Slide Series № 9

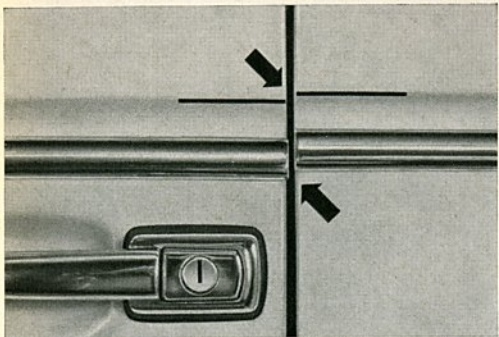
9/3 Inefficient servicing can often result in leaks and noises and it is often possible to eliminate two complaints of the same time. The first example: The arrow points towards the incorrect door gap. In the upper region the door nearly bears on the lock pillar whereas the gap shown by the lower arrow is too large.

9/4 The striker plate has to be removed when commencing with door adjustments as otherwise the door fit cannot be correctly checked. The waistline shown here is very helpful. The better the door fits with the striker plate removed the less corrections will have to be made later when adjusting the striker plate. This fact also lengthens the life of the lock.

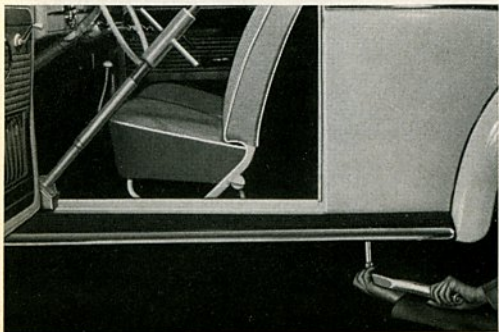
9/5 Here you see expanders being positioned in the door opening. In the case of an incorrectly fitting door, the door opening and not the door itself has altered. This alteration has been caused by the body which has settled.

First of all loosen the chassis mounting bolts under the rear quarter panel. Now stretch the door opening until a heavy resistance is felt. Remove the expander and check the door fit.

9/6 If the door fits correctly, insert the expander again in the door opening and tension it slightly. Now tighten the chassis mounting bolts to prevent the door opening from altering its shape. Use a torque wrench and tighten the bolts to 14 ft. lbs.

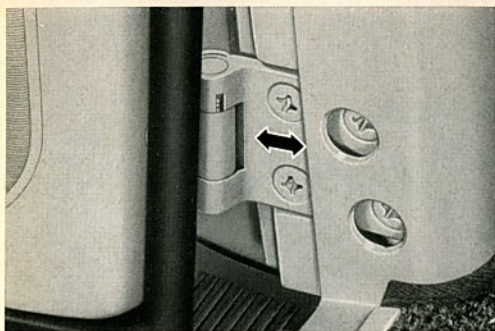
9/11 The ingress of water shown here would have been eliminated in an efficient workshop. It can be seen clearly that the door is protruding at the bottom whereas at the middle it is flush with the rear quarter panel.

9/12 In most cases it is sufficient to reposition the hinges outwards or inwards. In this case the lower hinge is loosened and moved inwards.

Make sure that the hinge screws are tightened fully.

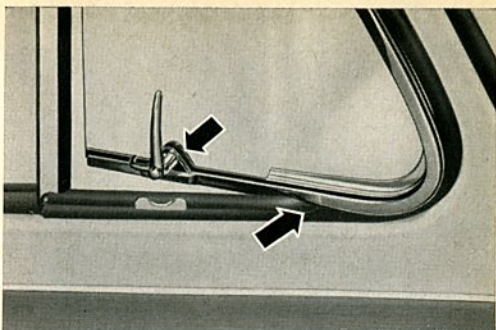
9/15 Even with the striker plate correctly adjusted it is possible for door leaks to occur.

A stiff vent wing regularly causes the frame to bend and results in leaks between glass and weatherstrip as shown by the upper arrow.

In this case, free the vent wing at the location shown by the lower arrow by adjusting the clamp and straightening the frame so that it bears evenly against the weatherstrip.

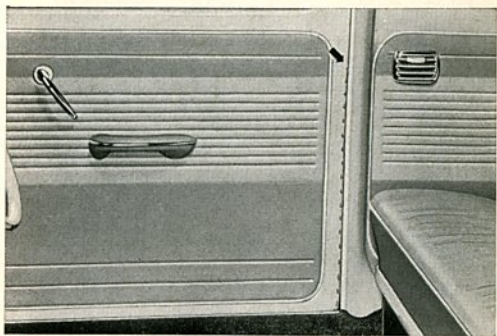
9/17 If the weatherstrip in the region of the lock does not bear evenly against the lock pillar, water can run along the inner door edge to the side member and collect there.

9/19 This complaint can be eliminated by bending the door hinges. This is done by inserting a hardwood block at the upper hinge and pushing the door firmly.

If the lower hinge is to be bent, it is advisable to remove the front fender. A wooden block is held against the hinge and tapped lightly with a hammer until the hinge moves sufficiently to ensure the correct door gap.

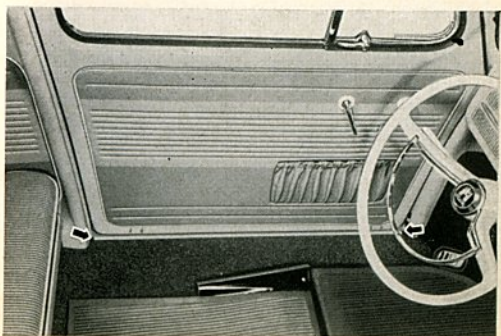
9/18 Once the water has reached the side member the carpeting will act as a wick at the locations shown by the arrows and eventually get under the floor mats.

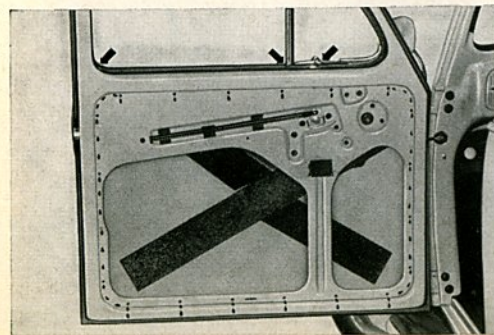
9/21 This has actually happened here. The waterproof paper has become loose and prevented the water from draining off.

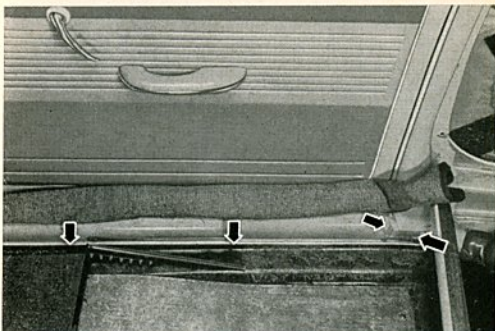
9/24 This also applies to the side member seams. Water which has seeped through the outer body skin often collects in the side member and leaks through at the locations shown here.

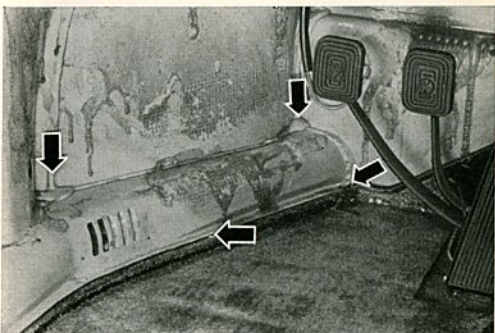
9/25 Splash water from the front wheels would be visible at these points. The two upper arrows indicate the danger spots on the front panel and the lower right arrow the joint of the frame seal between floor plate and front cross member.

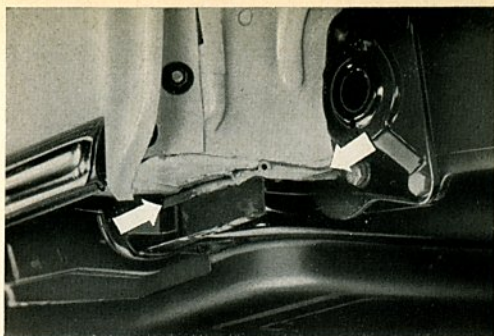
9/31 If water enters the vehicle at the joint of the body seal, Genuine VW Sealing Compound should be applied at the points shown here. The metal edge above the seal occasionally cause leaks.

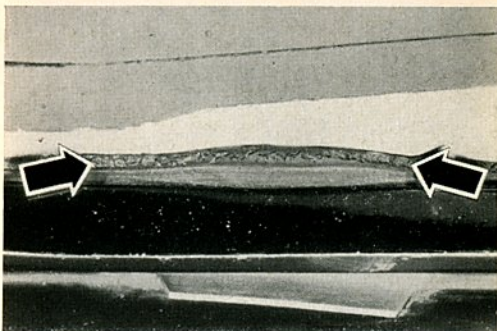
9/32 A damaged body seal often causes leaks. A seal which has been crushed by overtightening the body mounting bolts cannot fulfill its purpose. The mounting bolts may only be tightened with a torque wrench.

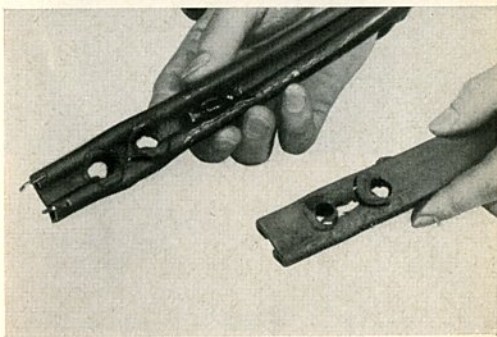
9/33 That is what the seal looked like on removal.

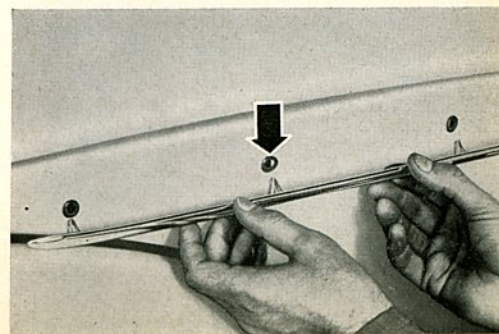
9/41 If leaks occur at the mouldings, the rubber caps are damaged. The arrow indicates a cap which has been cut by the sharp metal and now leaks.

9/42 It is quite obvious that this cap must be replaced. Make sure that it is inserted into the hole prior to the installation of the moulding. Clean up the sharp edge beforehand.

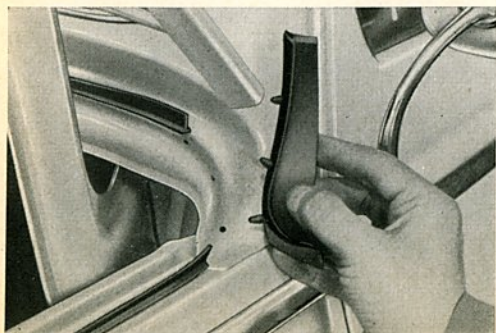
9/45 In the event of the front hood leaking, the water usually gets in at the top corners and consequently into the side members as we have previously described.

The best method of eliminating this is by cementing rubber seals to the corners of the cowl panel.

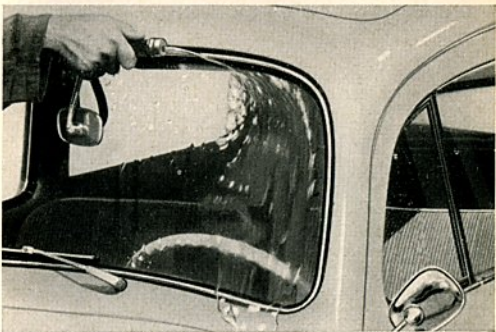
9/47 In this particular case the ingress of water was evident at the windshield. Leaks at the windshield can result in the water running down behind the instrument to the side members and then under the floor mats.

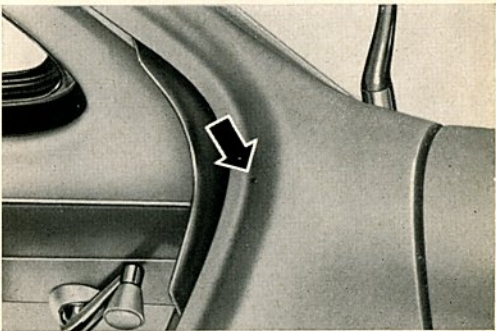
9/48 Due to a damaged and porous weatherstrip the water got in through this hole.

During the prime coating process the paint drains off here.
