Adjustments on Convertible Top

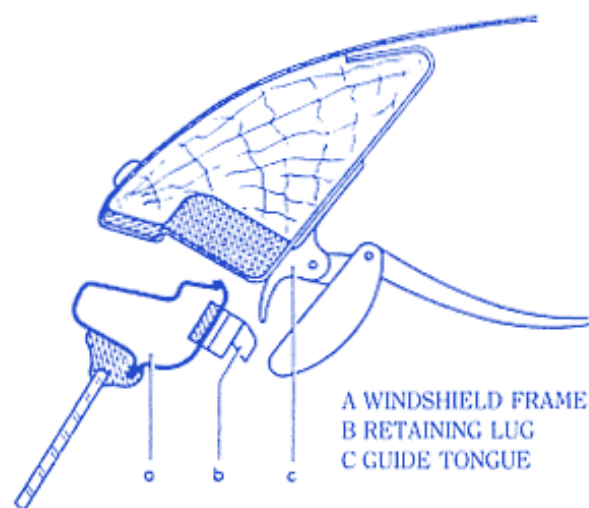
A Guide tongues of both top locks strike the bottom part of the retaining lugs.

If the guide tongues of the top locks strike the retaining lugs when the top is closed, check whether the roof side members are located properly on the window frames and if the gap between the quarter panel and the doors widens towards the top.

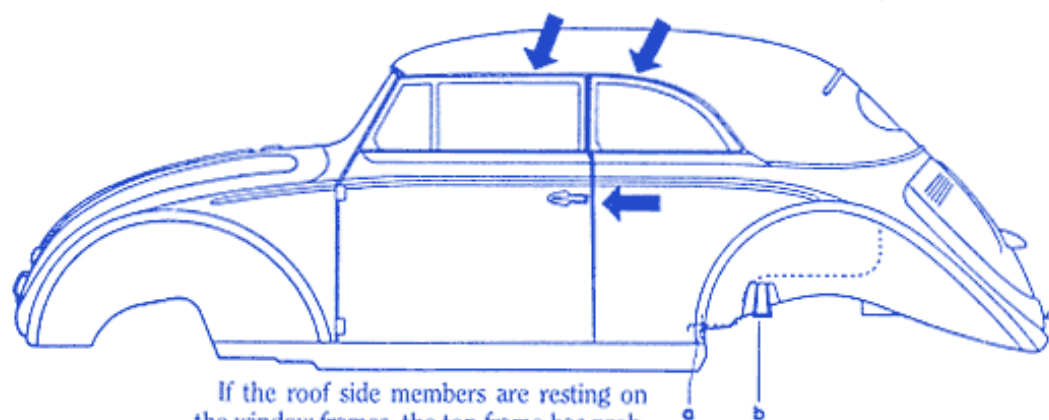
If the roof side members are resting on the window frames, the top frame has probably been damaged by being opened in a careless manner. In this case straighten the side members cold as required.

If the door gaps widen towards the top, loosen the body securing screws and remove them at points **a** and **b**. Place hard rubber packing pieces about 3 mm thick under the body support brackets on both sides. Tighten the body bolts again to 3 mkg (22 ft. lb.) torque. If the door gaps are still not the correct width, thicker packings must be used.

Should the roof side member location and the door gap both be in order, the guide tongues of the top locks can be bent slightly to the front or small leather pieces inserted under the bottom part of the locks until the guide tongues enter correctly.

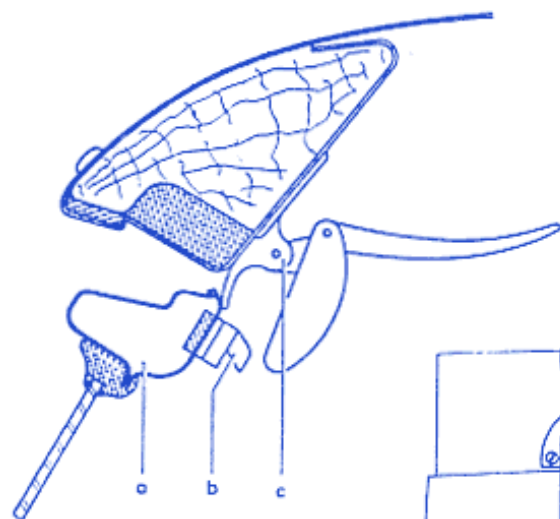
B Guide tongues of both top locks strike the windshield frame

If the guide tongues of the top locks strike the windshield frame when the top cover is properly tensioned, small leather pieces should be inserted under the locks until the guide tongues enter correctly. Otherwise—particularly on older vehicles, it is necessary to re-tension the top cover on the header.
