1955 Beetle Interior details

Reference and review for restoration target.

Rev 3

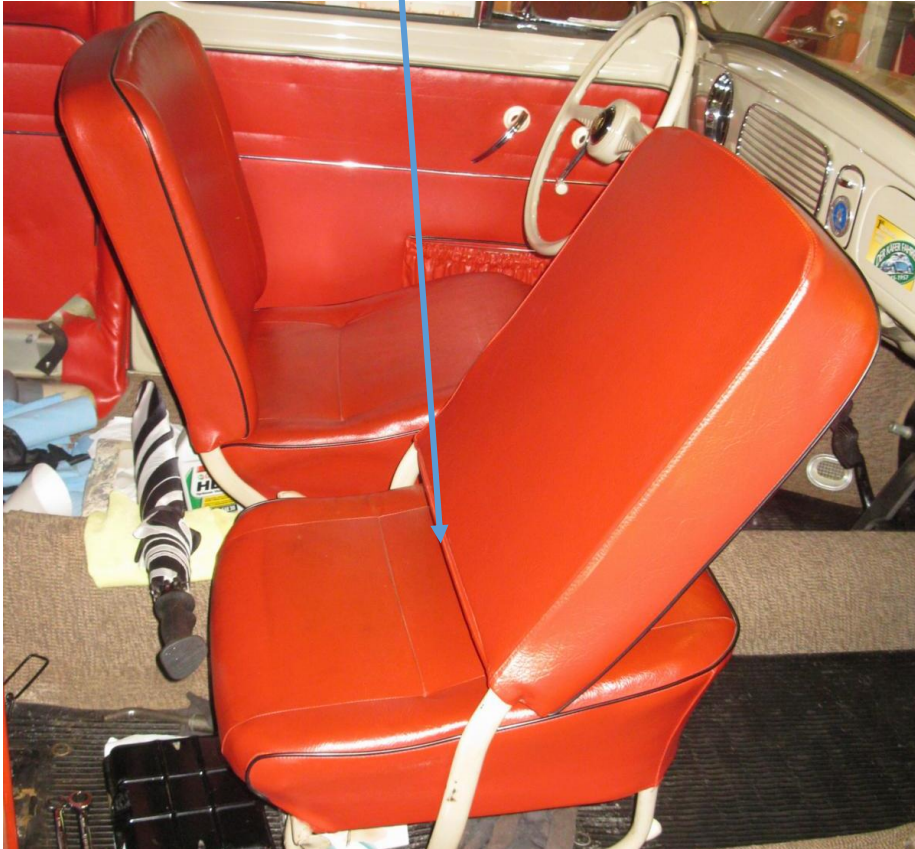
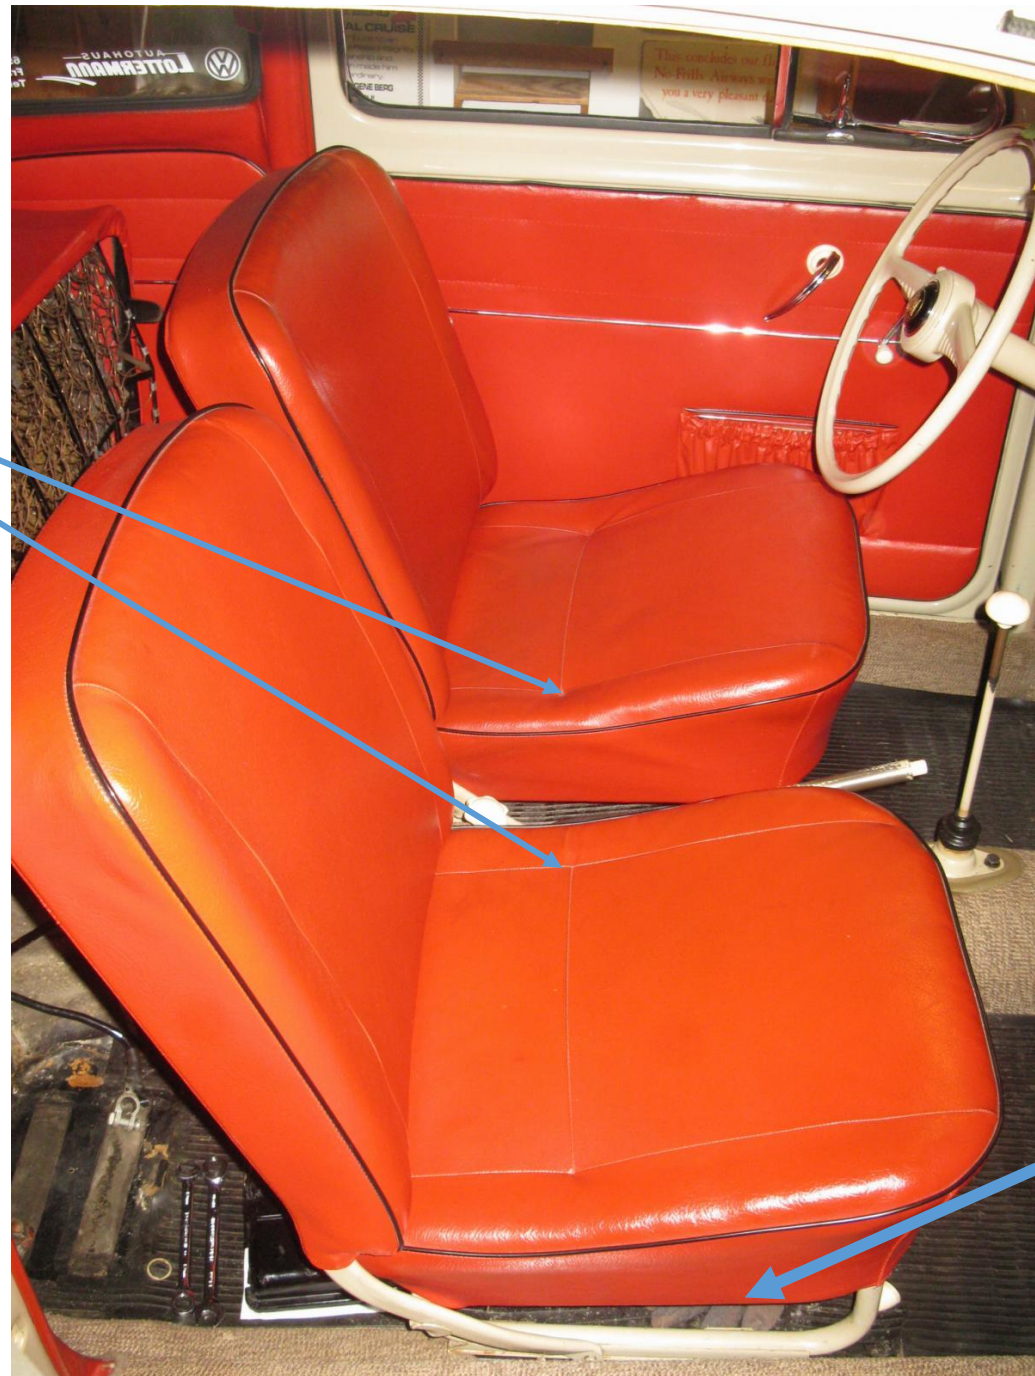
Front seats

1. Black piping on seat and backrest
2. Tied dimple at 2 positions of seat
3. Pinched closure at bottom of backrest
4. Seat bottom uses wire loop cinch closure.

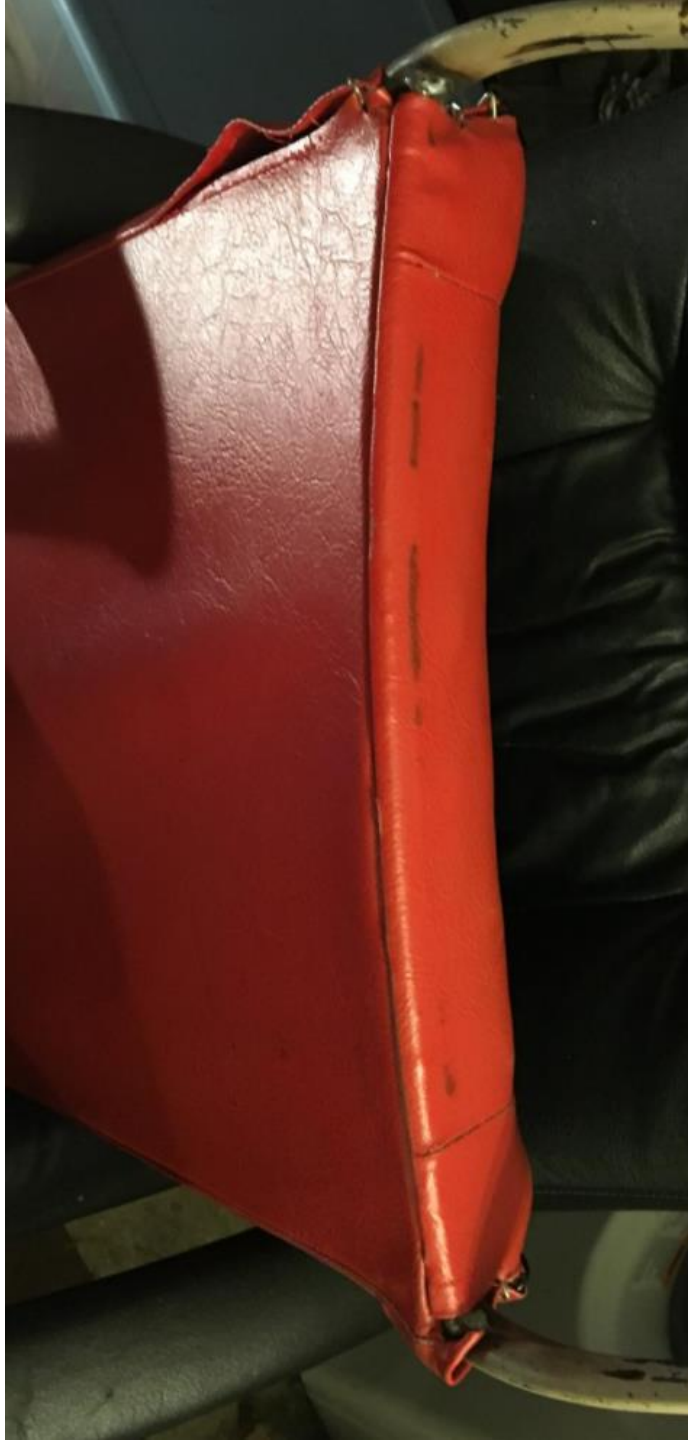
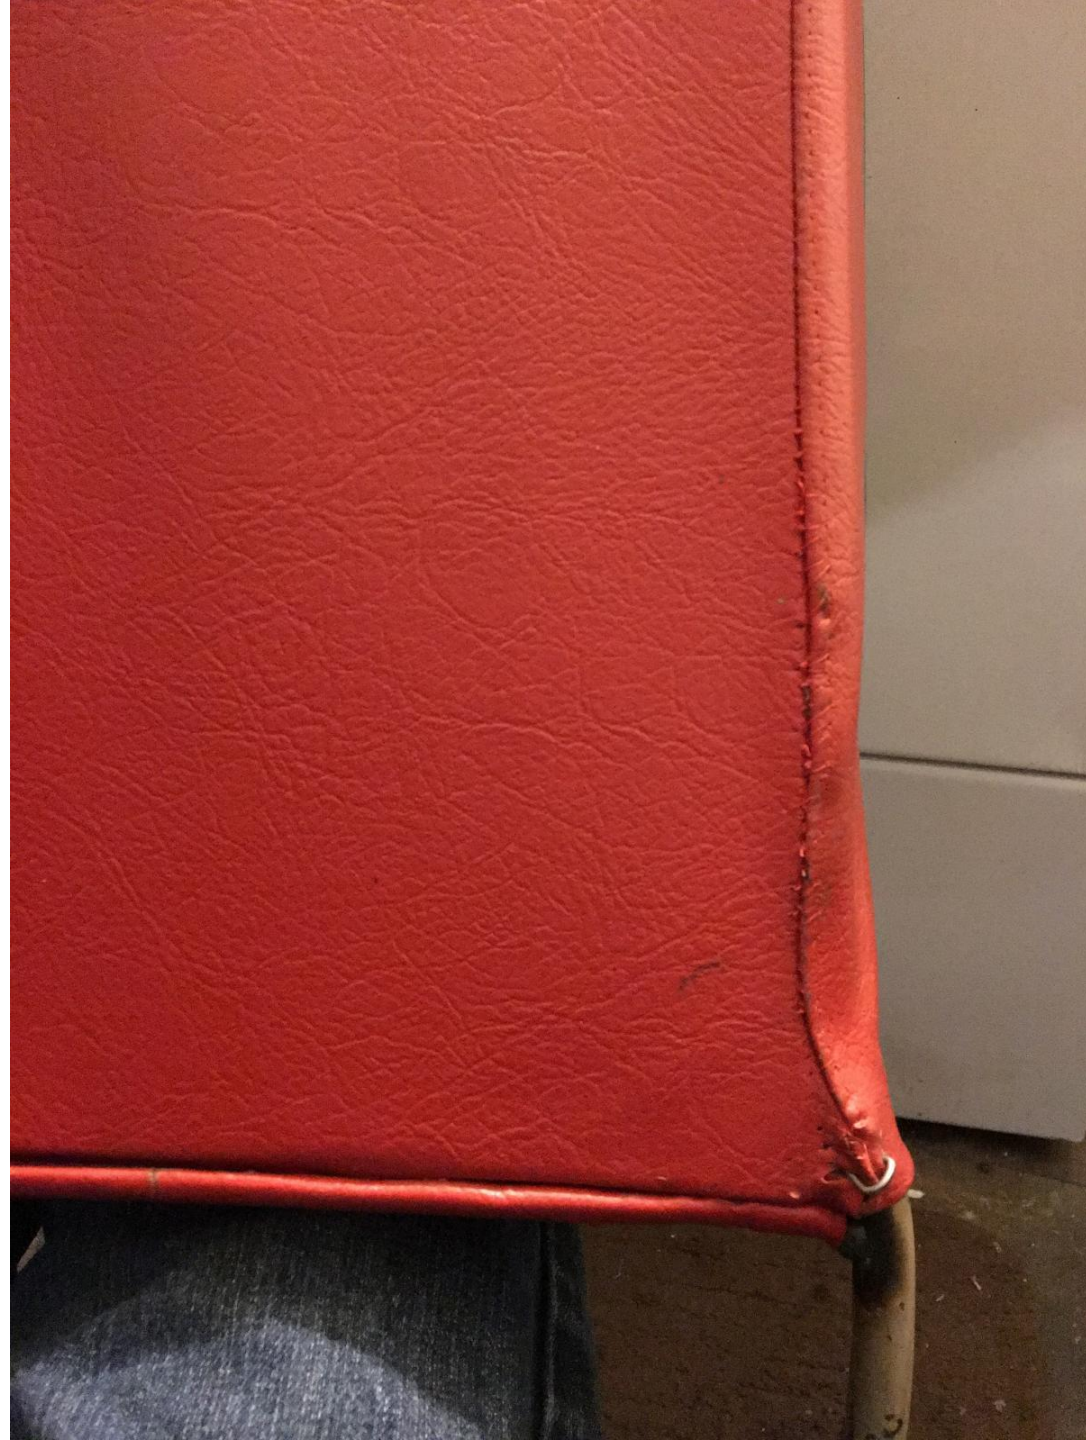
Wire tie loop
(choker) at seat
bottom is factory.

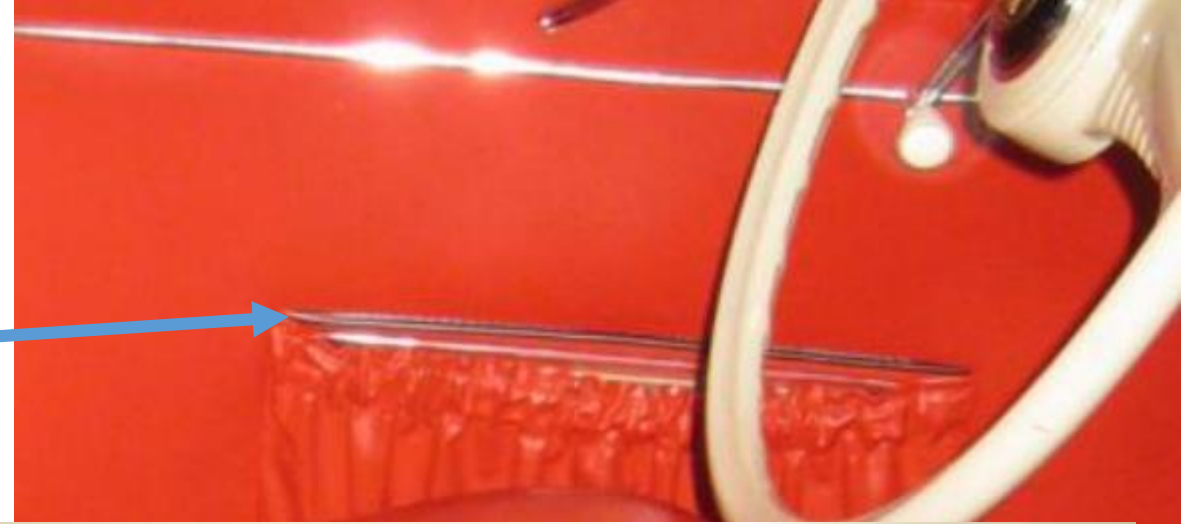
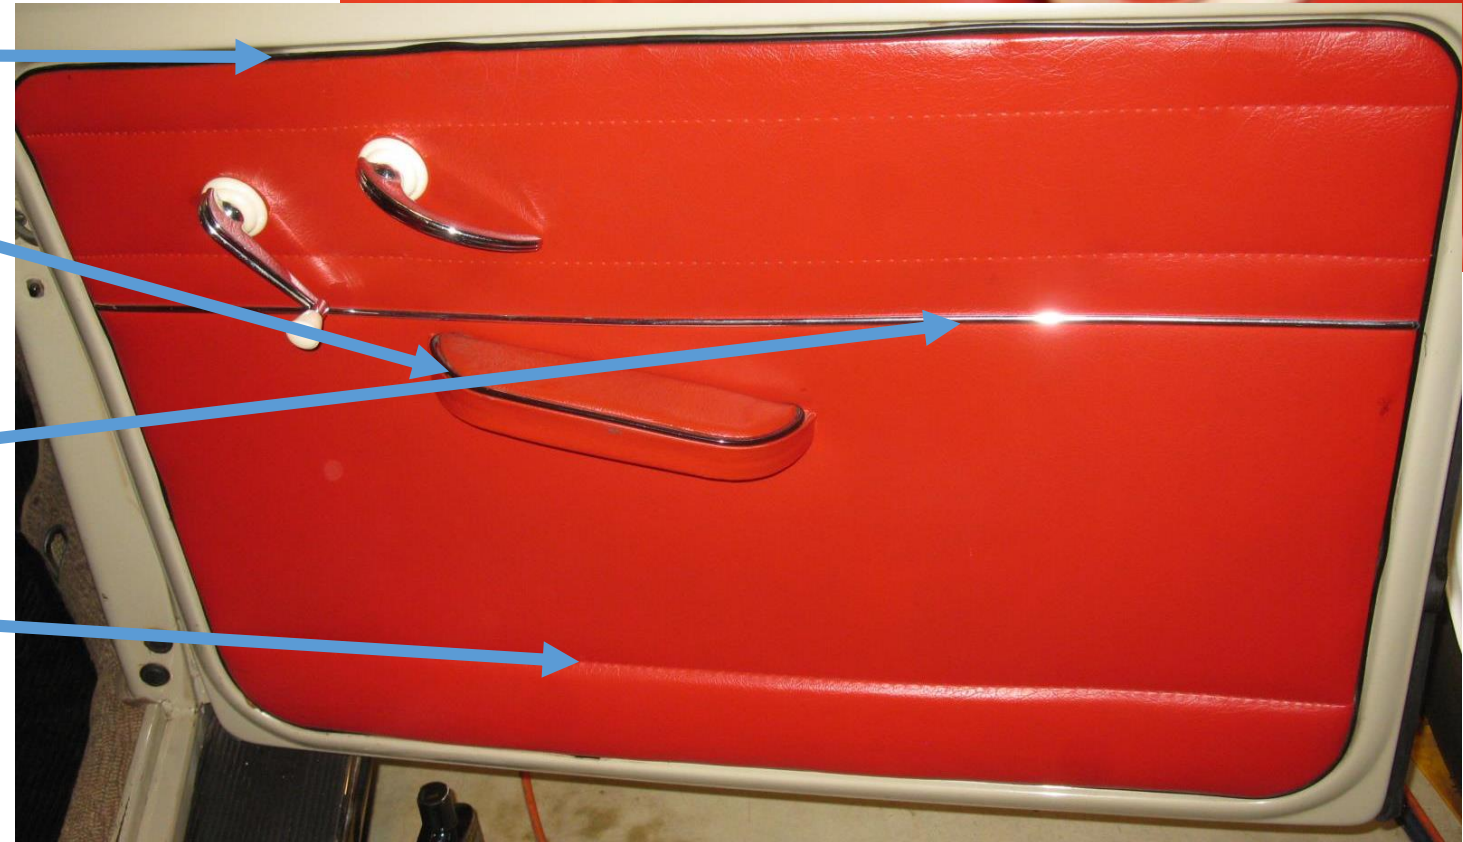
Door panels

- Piping at drivers side pocket
- Piping around perimeter
- Piping on armrest
- Marks or holes in hardboard for chrome trim?
Need position
- Sewn to hardboard 3x, thin padding only. NOT PUFFY.

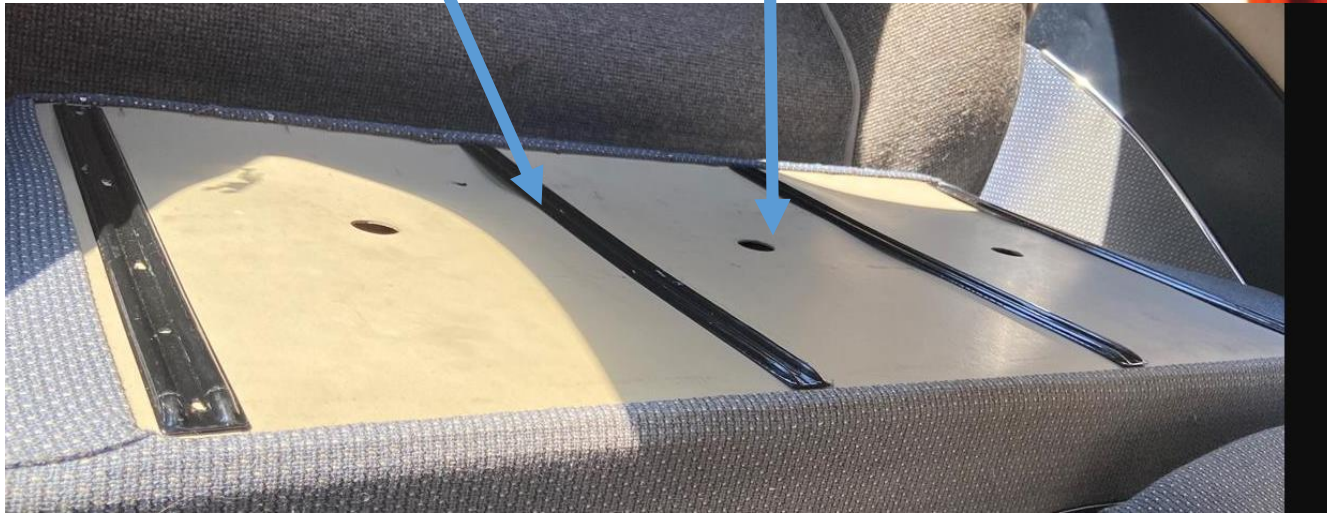
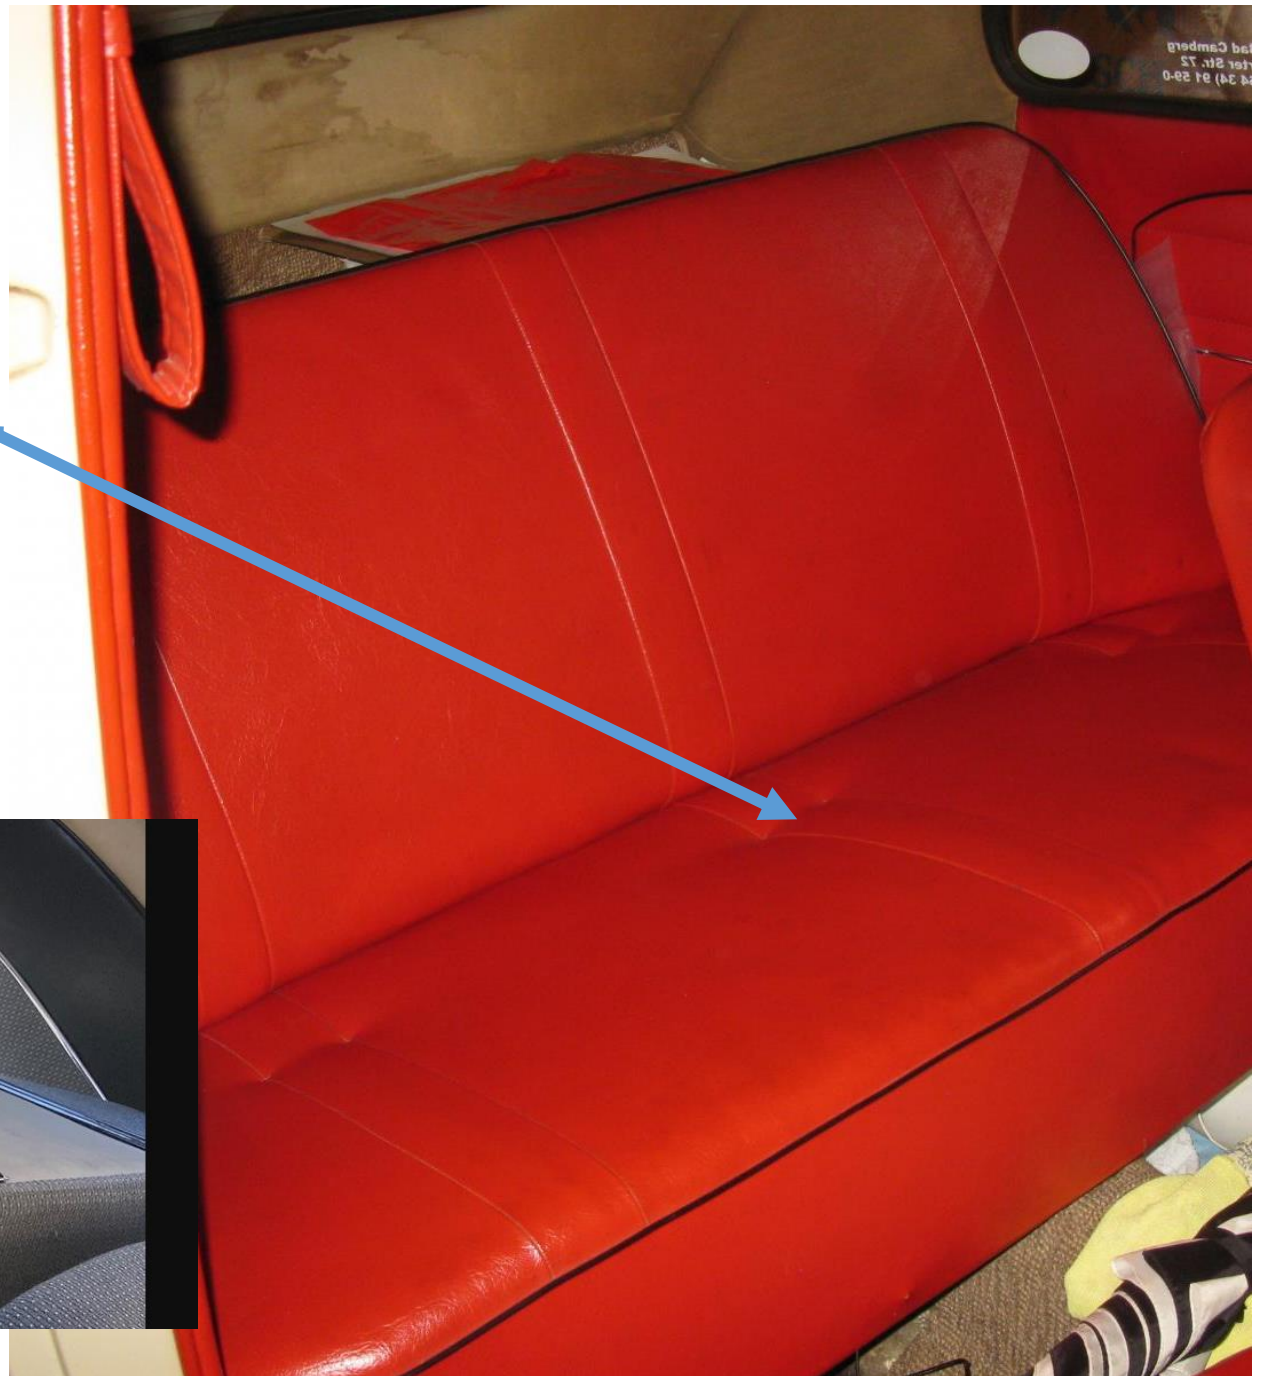
Back seat

- Dimple ties 6x
- Fiberboard back with 3 holes, sewn to fabric
- Need exact positions of the seat back rails

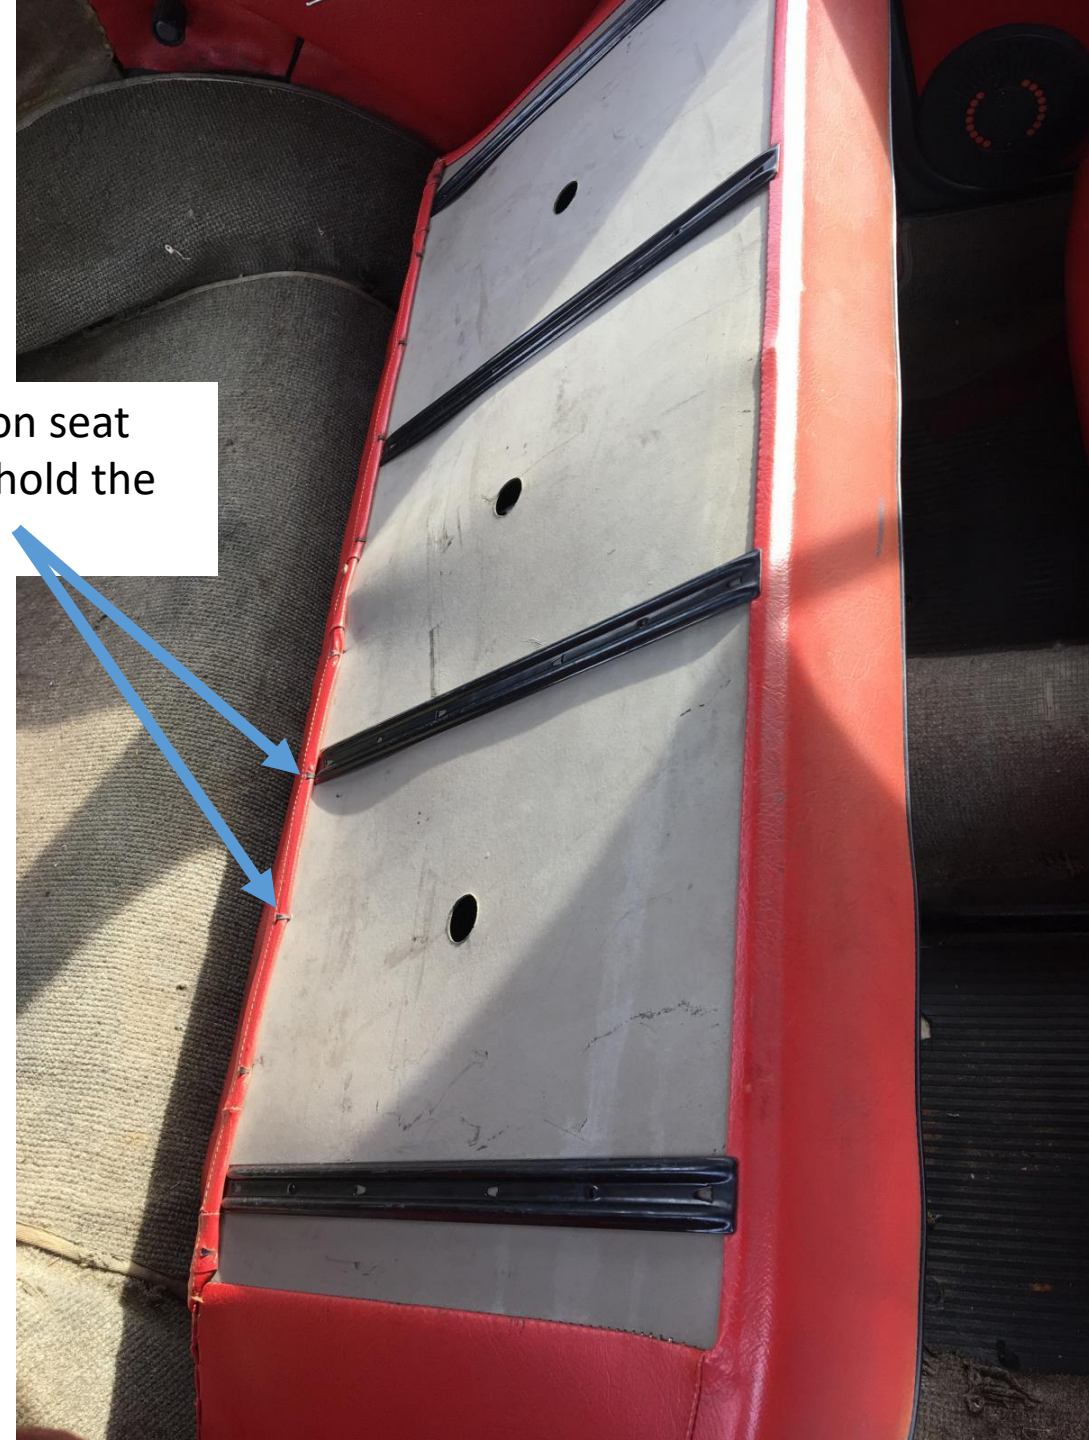
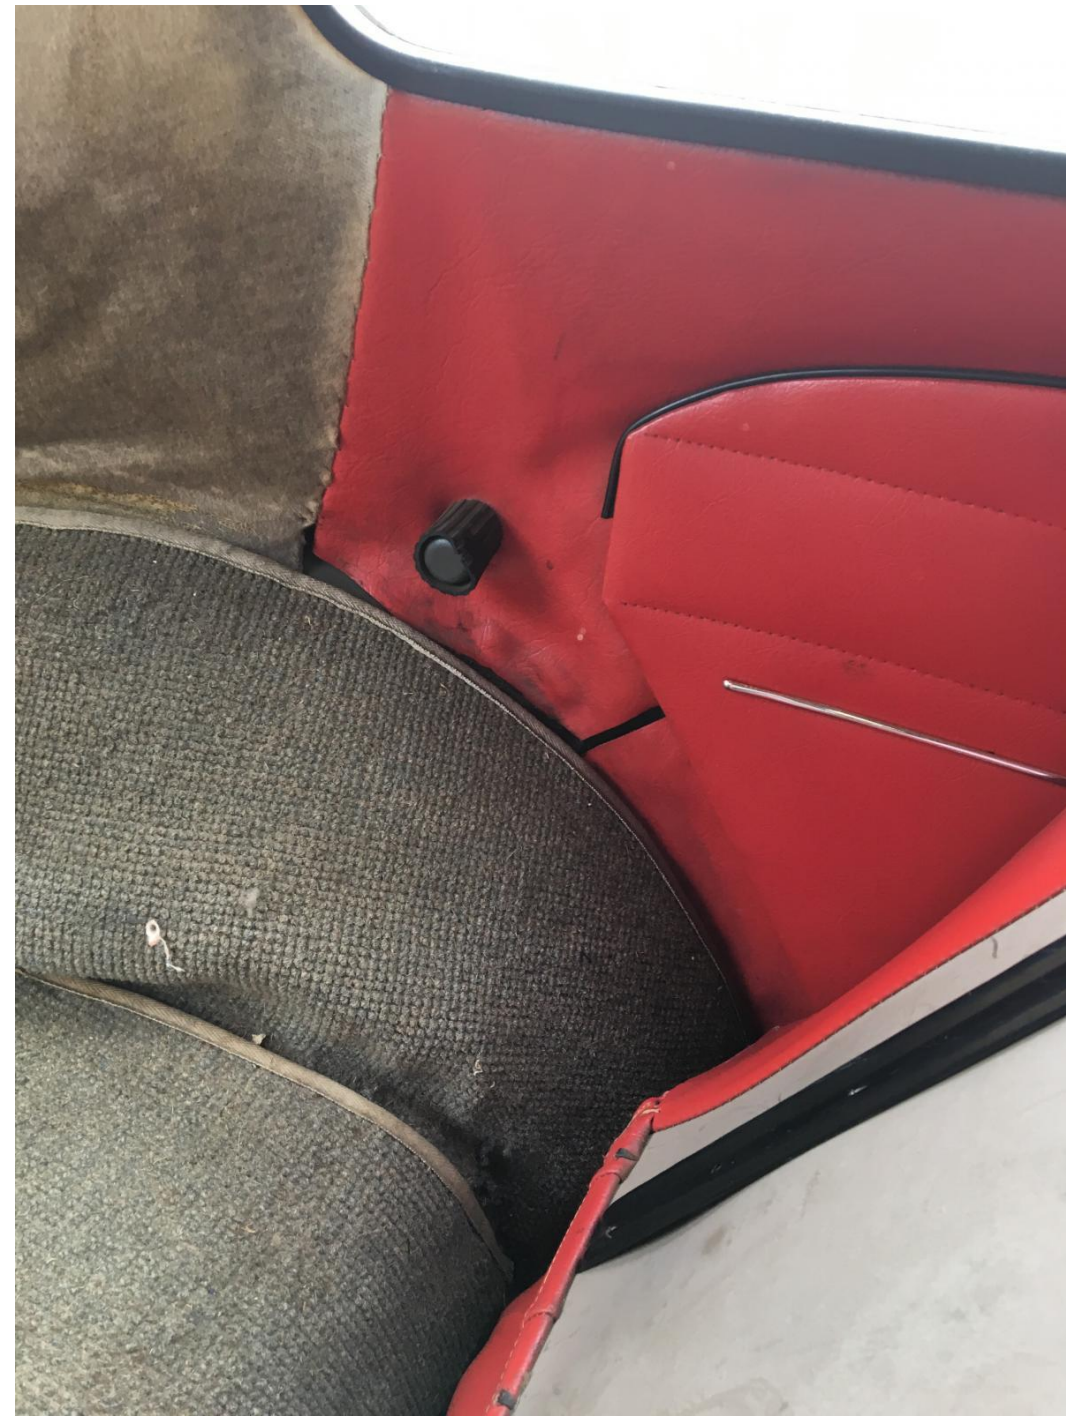
Barbs on seat
frame hold the
cover

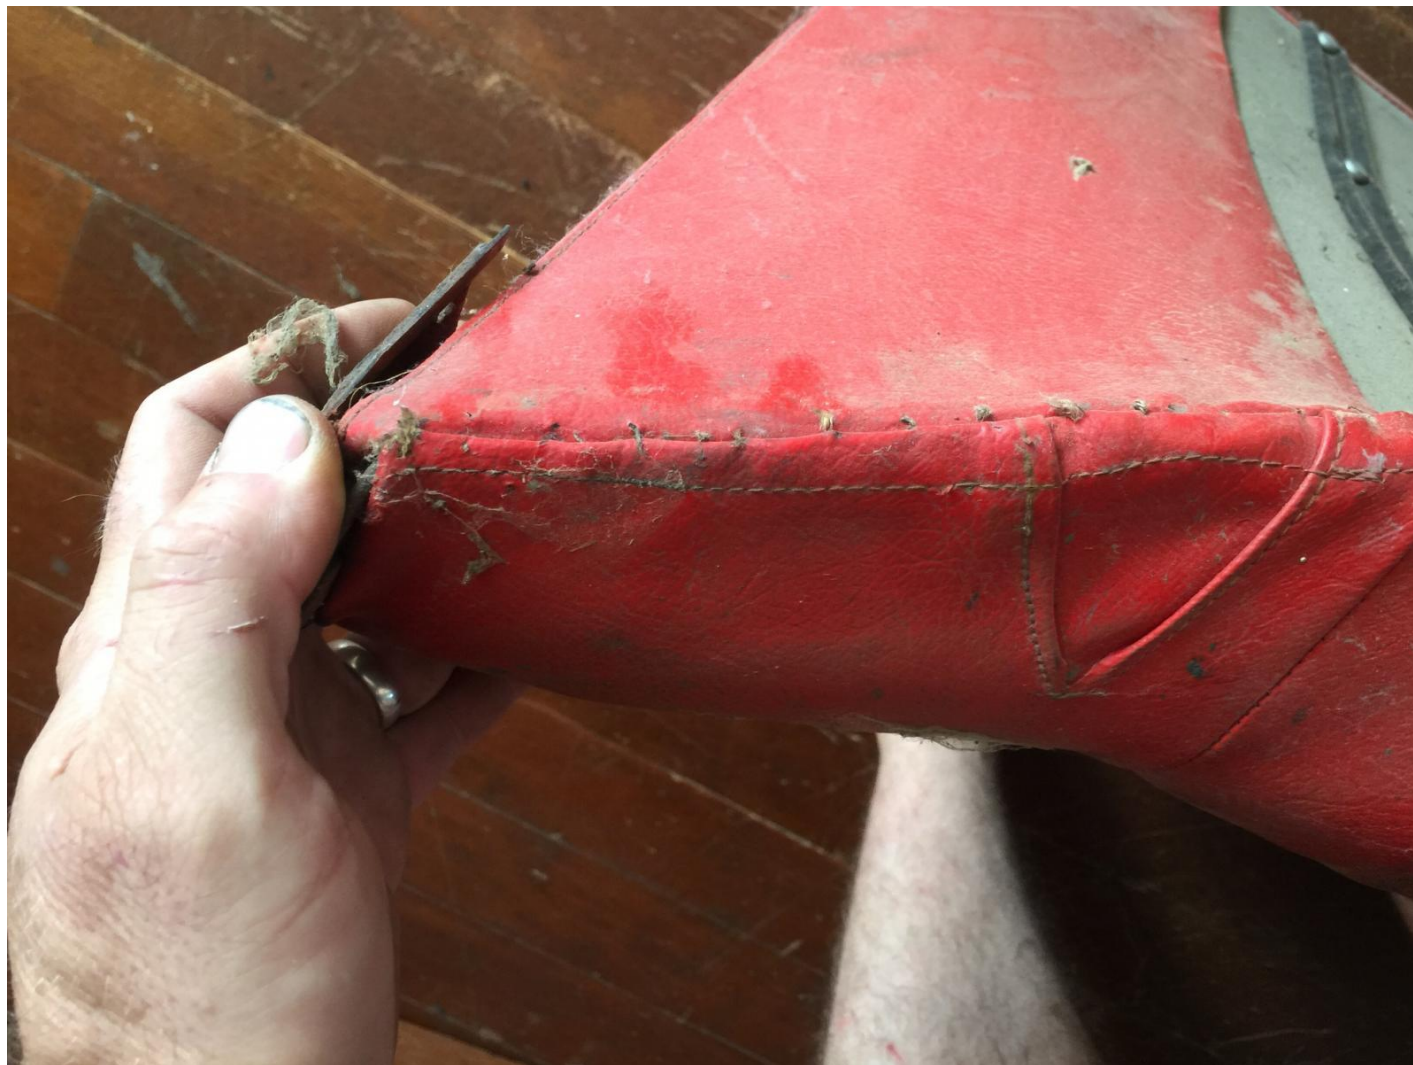
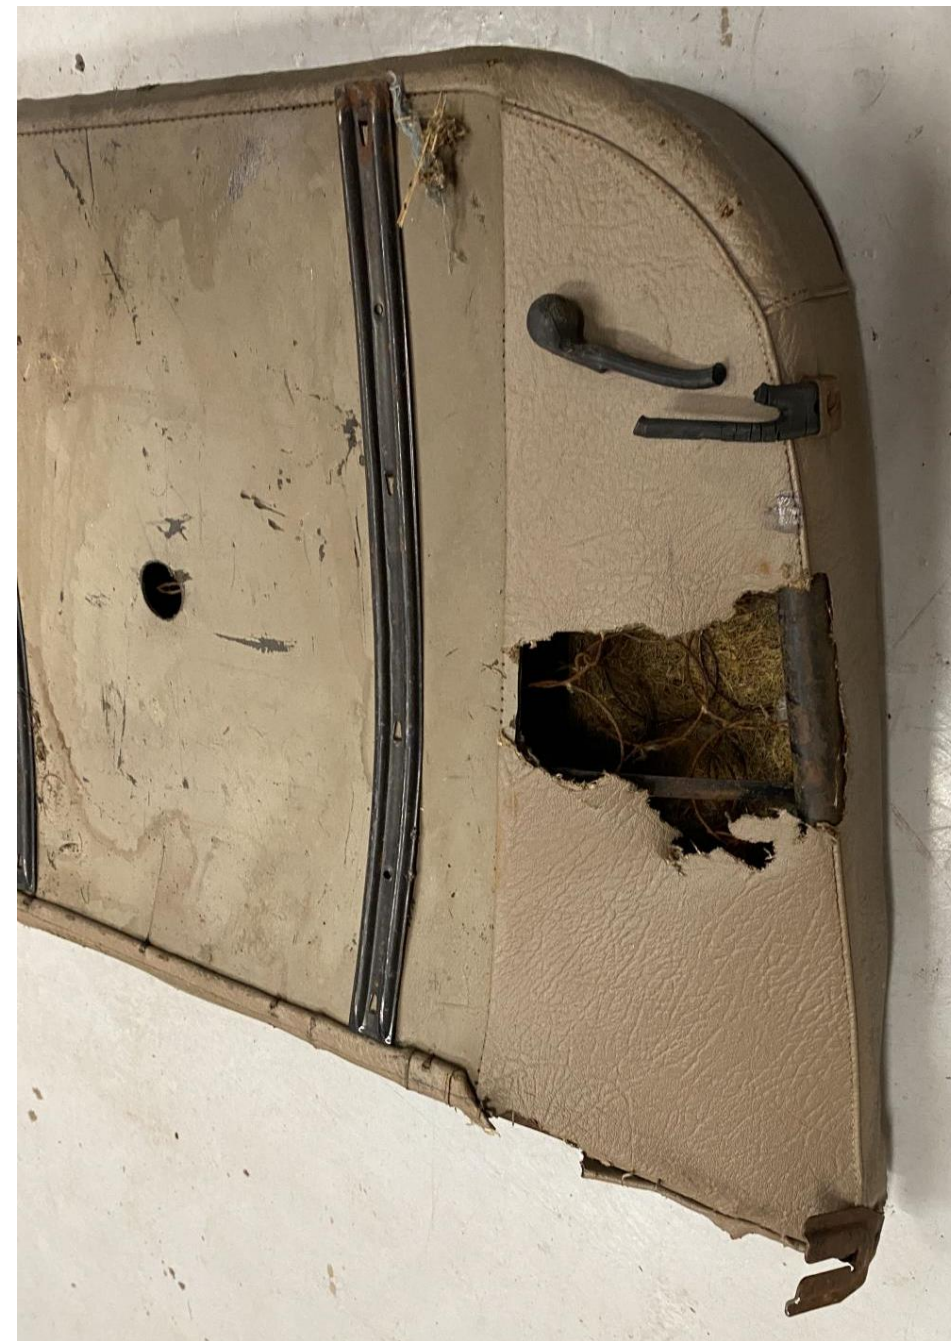
Back seat rest cover stitching

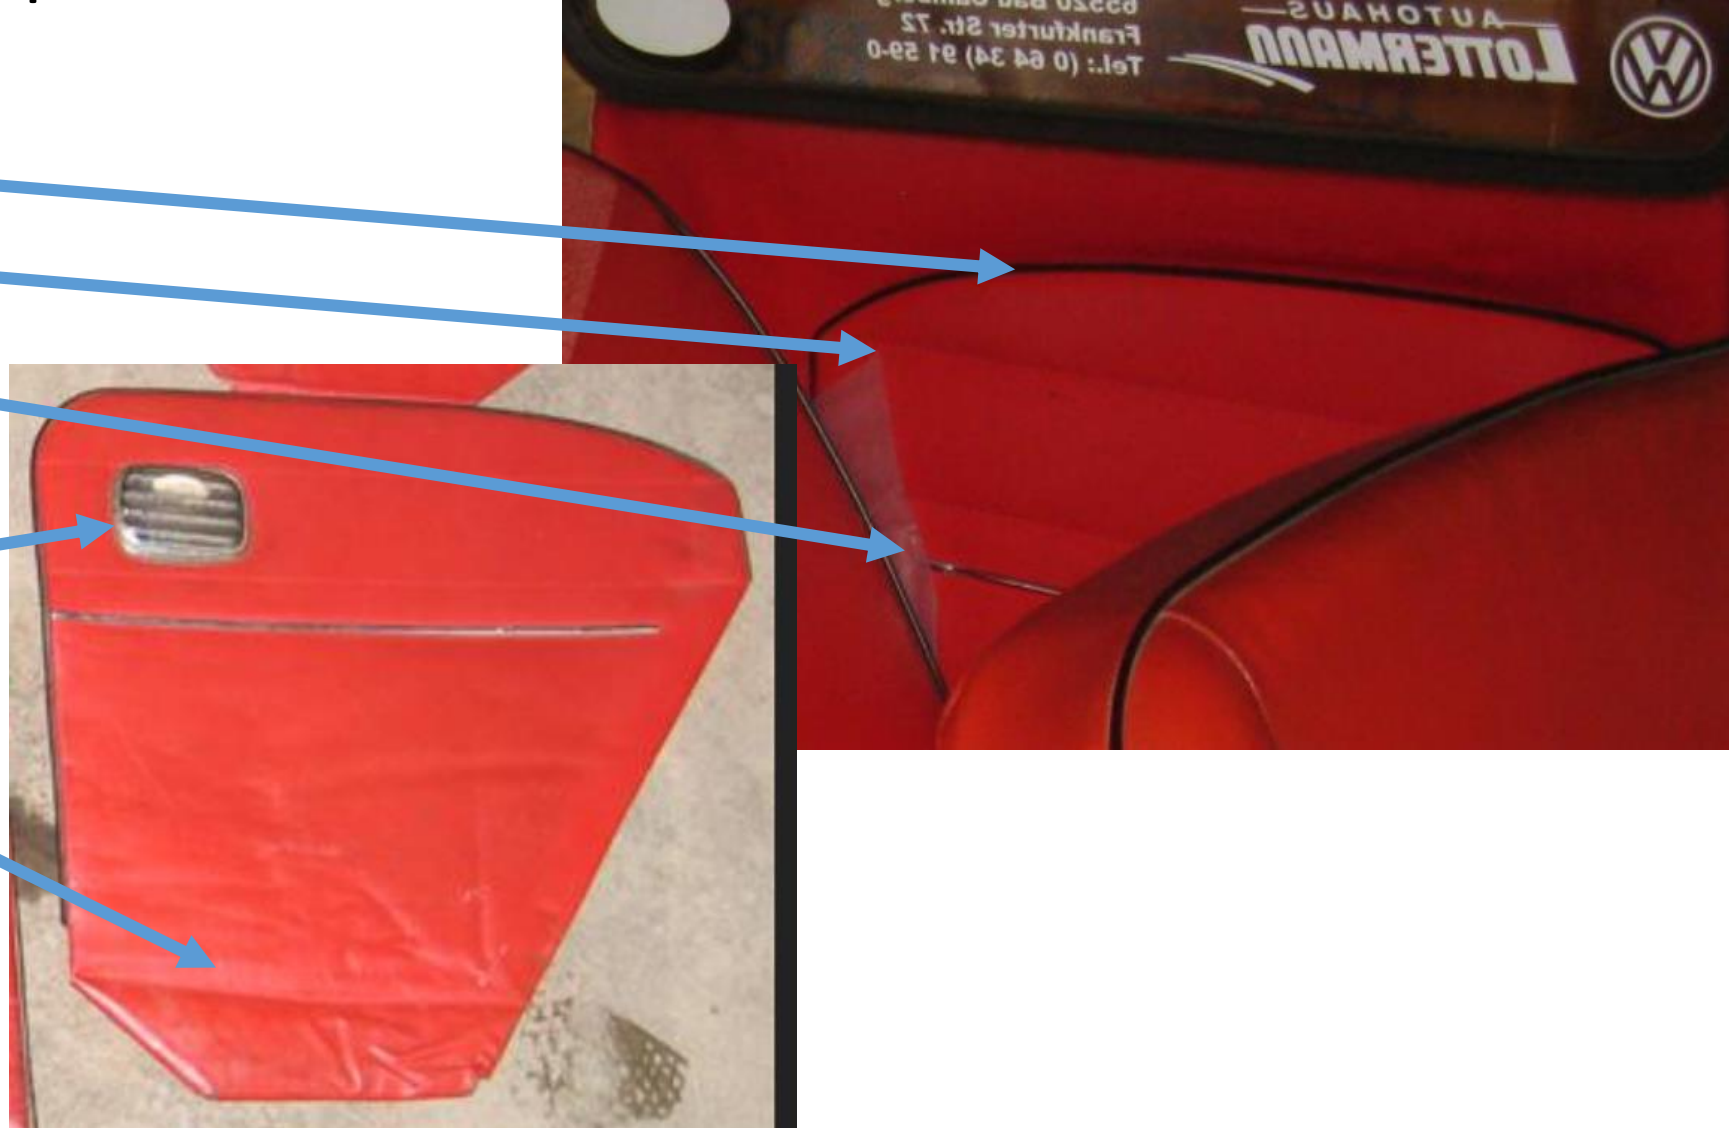
Rear interior panels

- Black piping
- Sewn to board
- Chrome trim
- Ash tray hole on right panel
- No sewn line down here
- Thin padding only (not puffy)

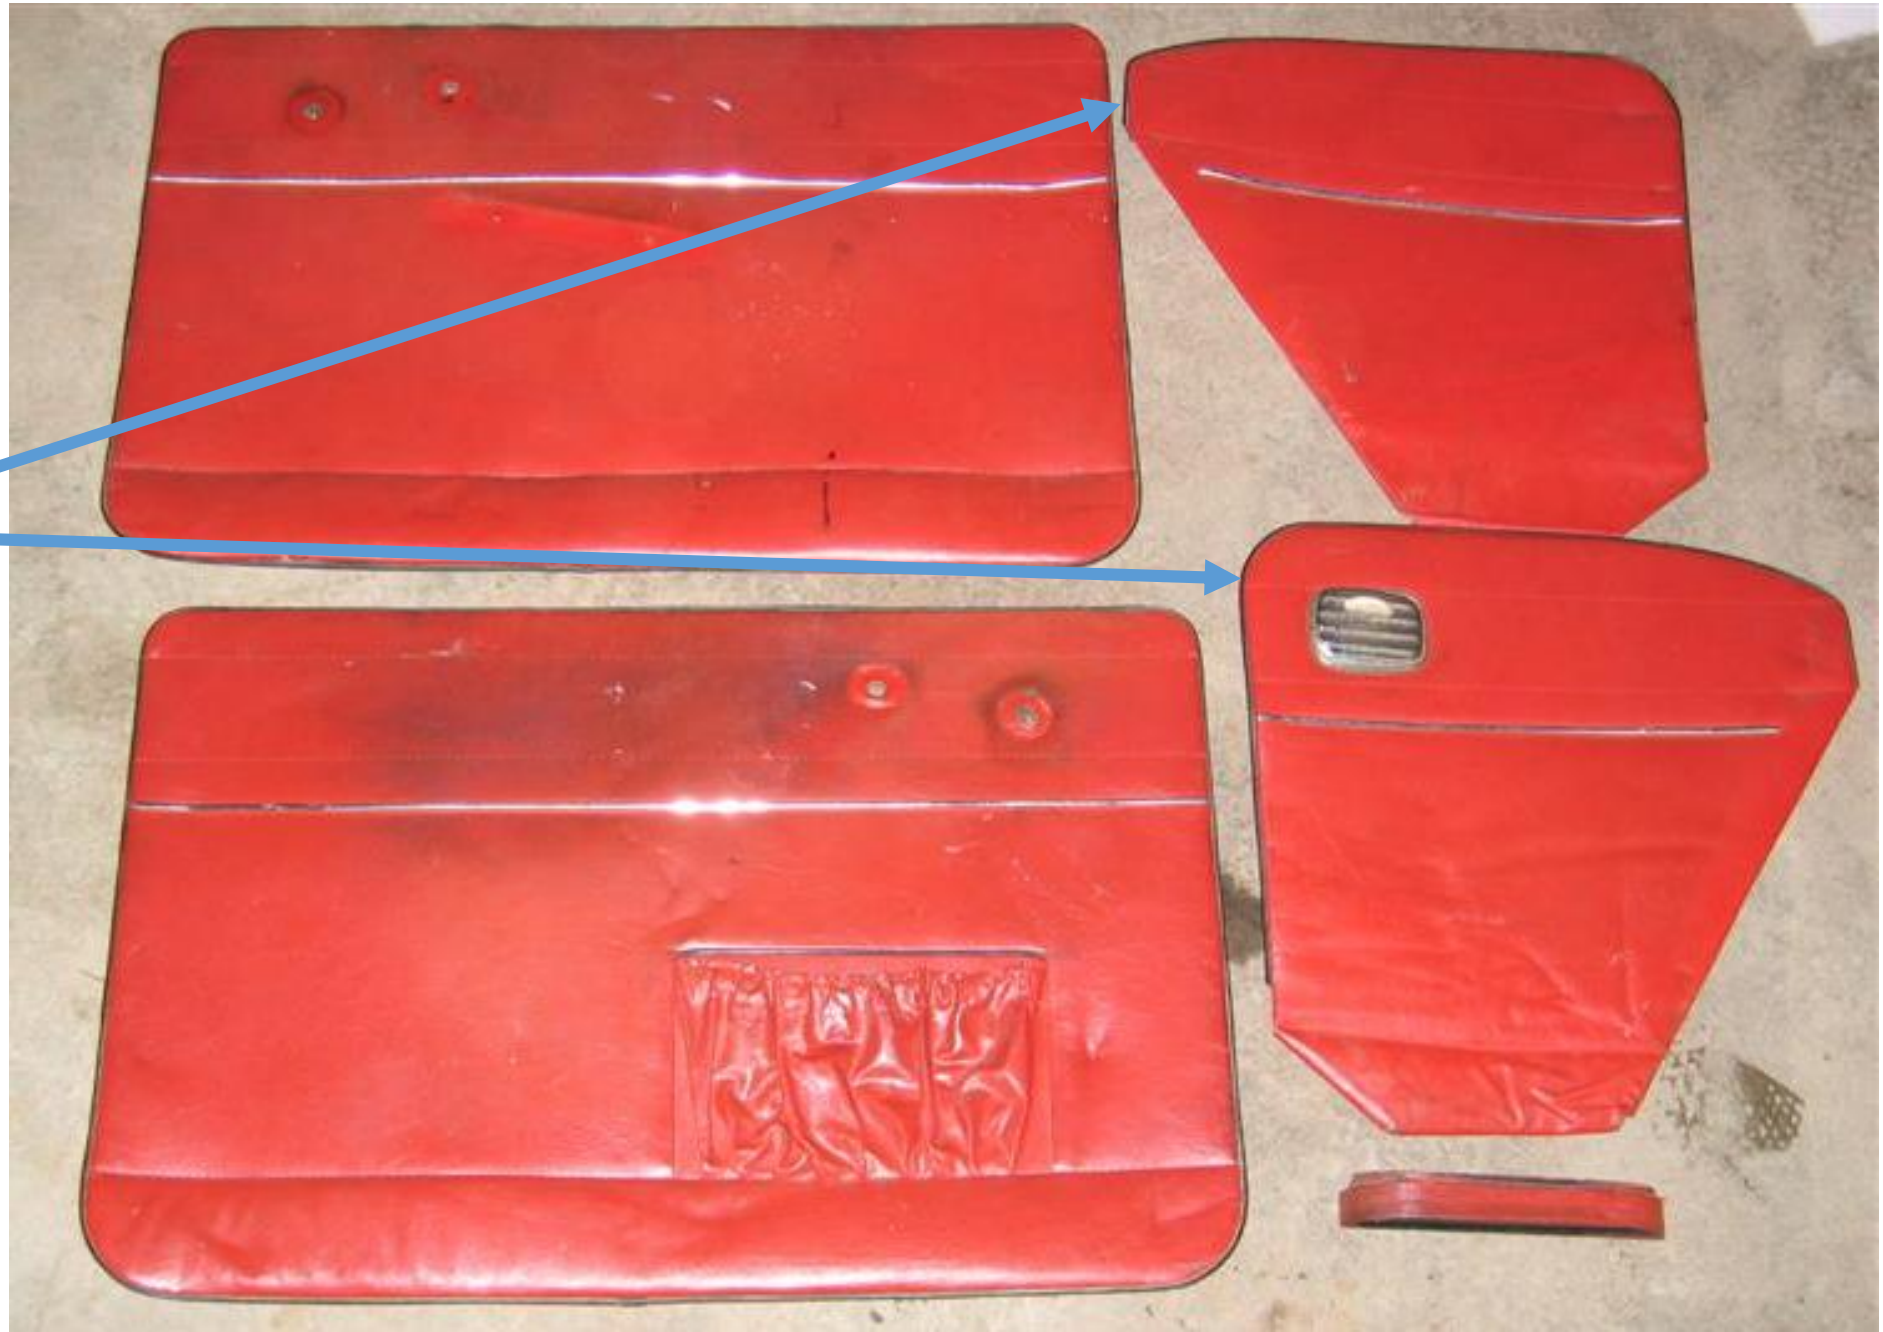
'55 panels

- Ash tray location looks vertically centered between the sewn lines.
- Note the piping location range on the back panels.
- Only 2 sewn lines on rear panels. They line up with front panel sew lines.
- Rear panel shape is same as these (straight bottom, corner and back edges)

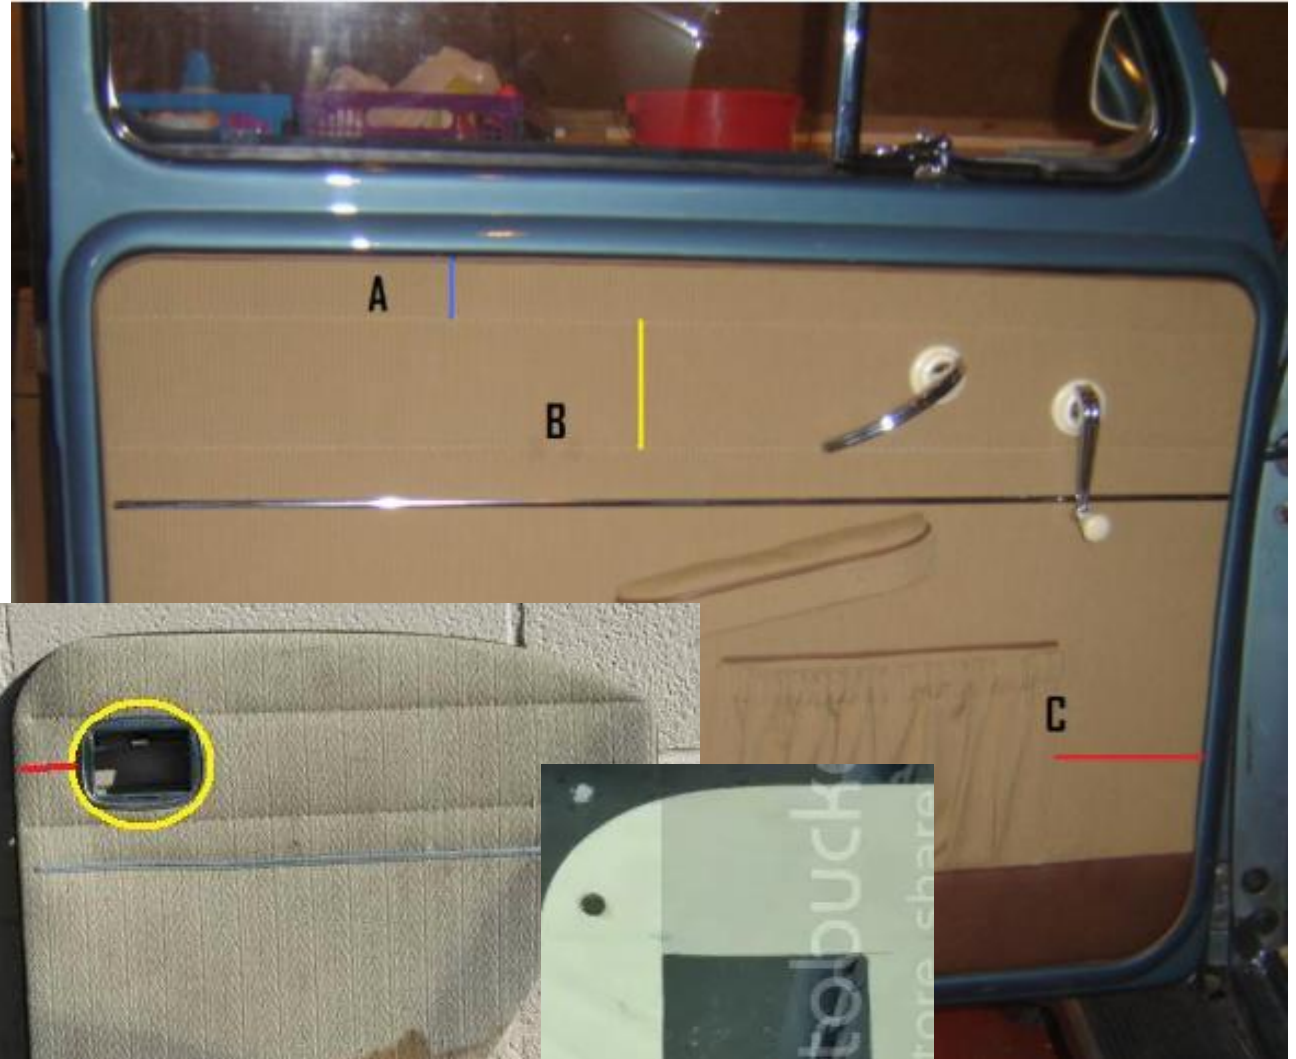
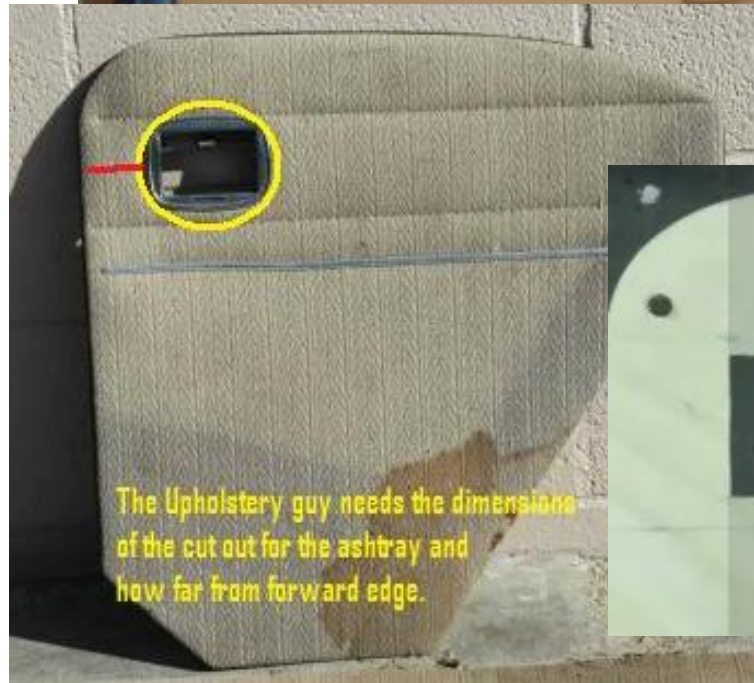
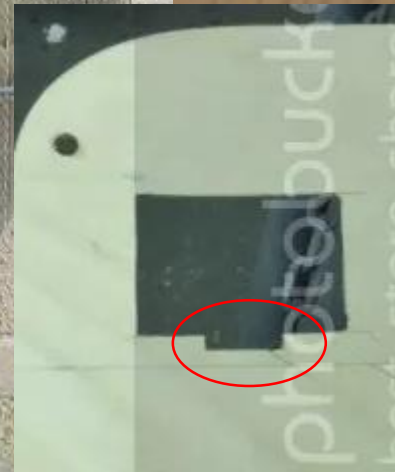
Found this info, Reference only

- A- Distance from the panel, NOT including piping, just the panel to the first seam.
- B-Then the distance from the first seam (A) to the second seam (B).
- C-The distance from the edge of the panel, NOT including piping to the forward edge of the map pocket (C).
- D-The measurement on the quarter panel of the ashtray cut out.
- E-The distance from the edge of the quarter panel NOT including piping to the forward edge of the ashtray.
- A- $1 \frac{7}{8}$
B- $3 \frac{1}{2}$
C- $5 \frac{3}{8}$
D- $2 \frac{1}{8} \times 3$ **with notch** (see photo)
E- $2 \frac{1}{2}$

The Upholstery guy needs the dimensions of the cut out for the ashtray and how far from forward edge.
