1955 Beetle Interior details

Reference and review for restoration target.

Rev 3

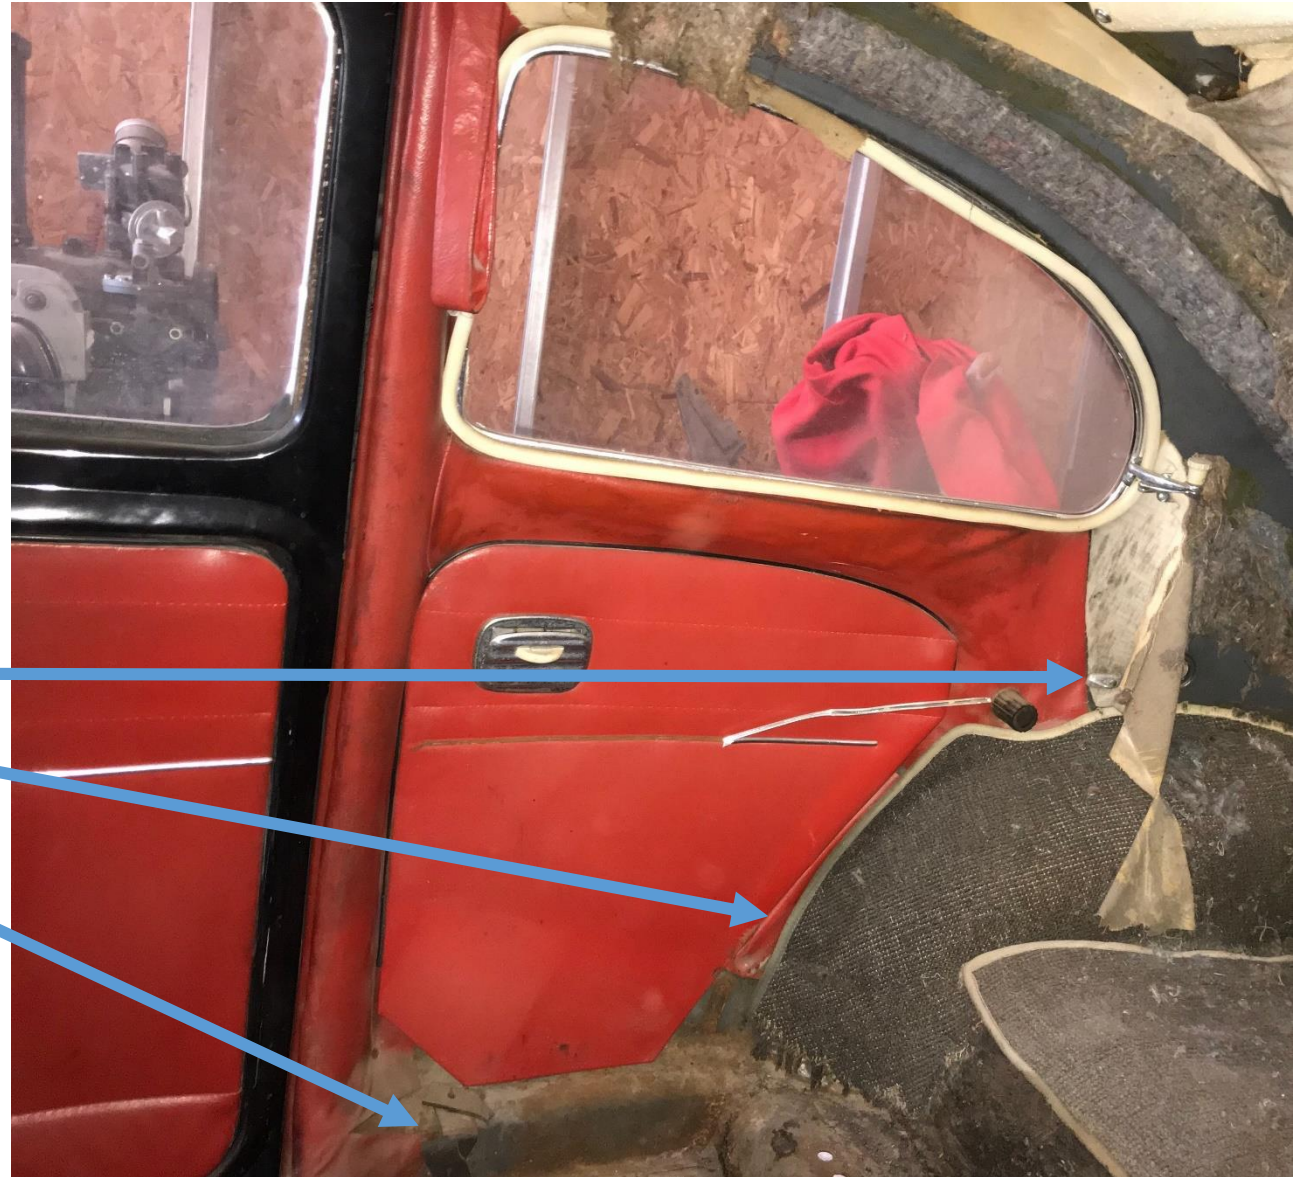
Another original rear interior quarter view 1953-1955

- Confirms line up of sewn through panel
- Chrome lines up with door
- Extent of pillar red cover

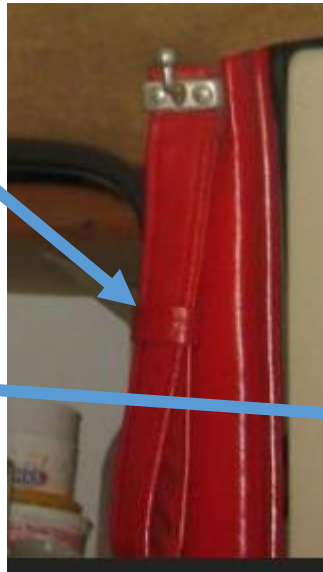
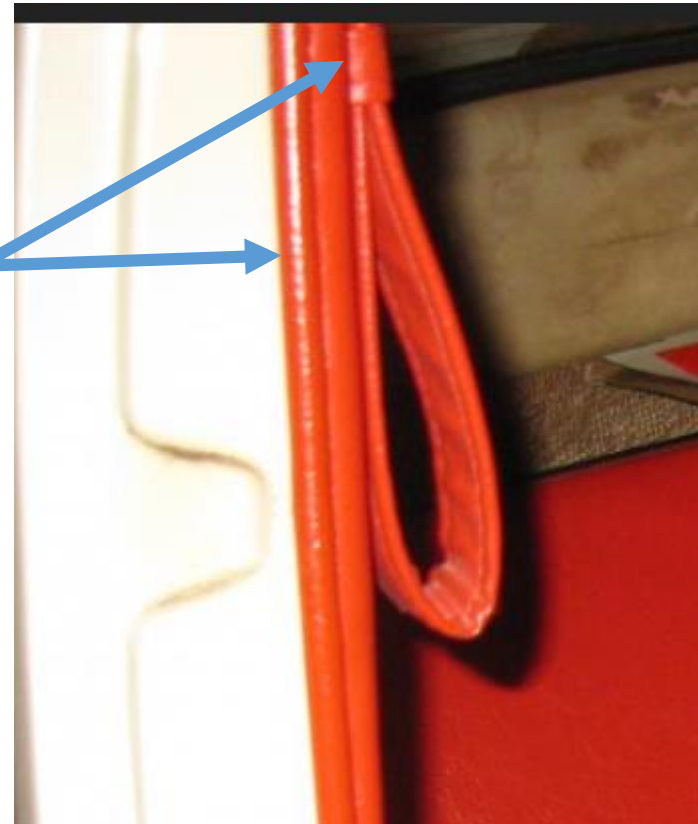
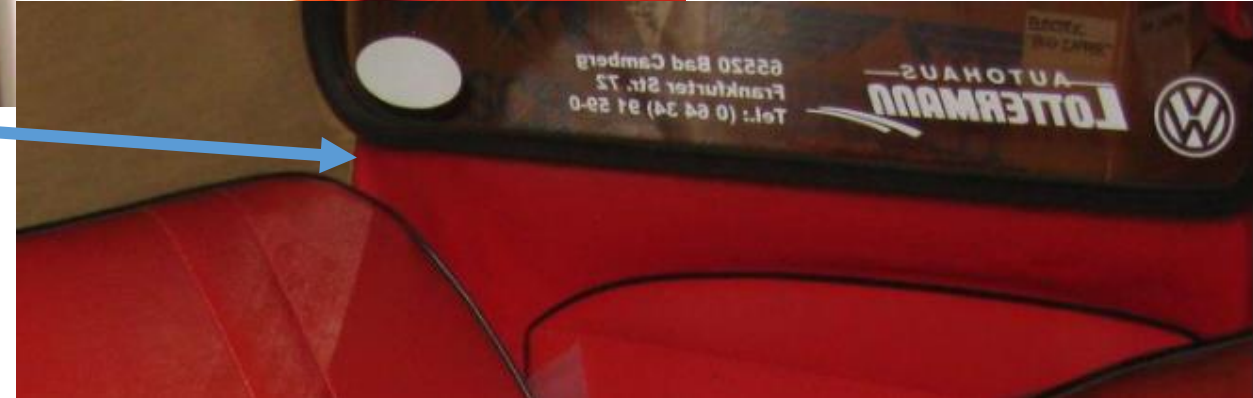
B-Pillar covering, Grab Handles

- Wrapped piping OK on pillar edge
- Sliding wrap on the grab handle main loop.
- Side covers go back to window bend

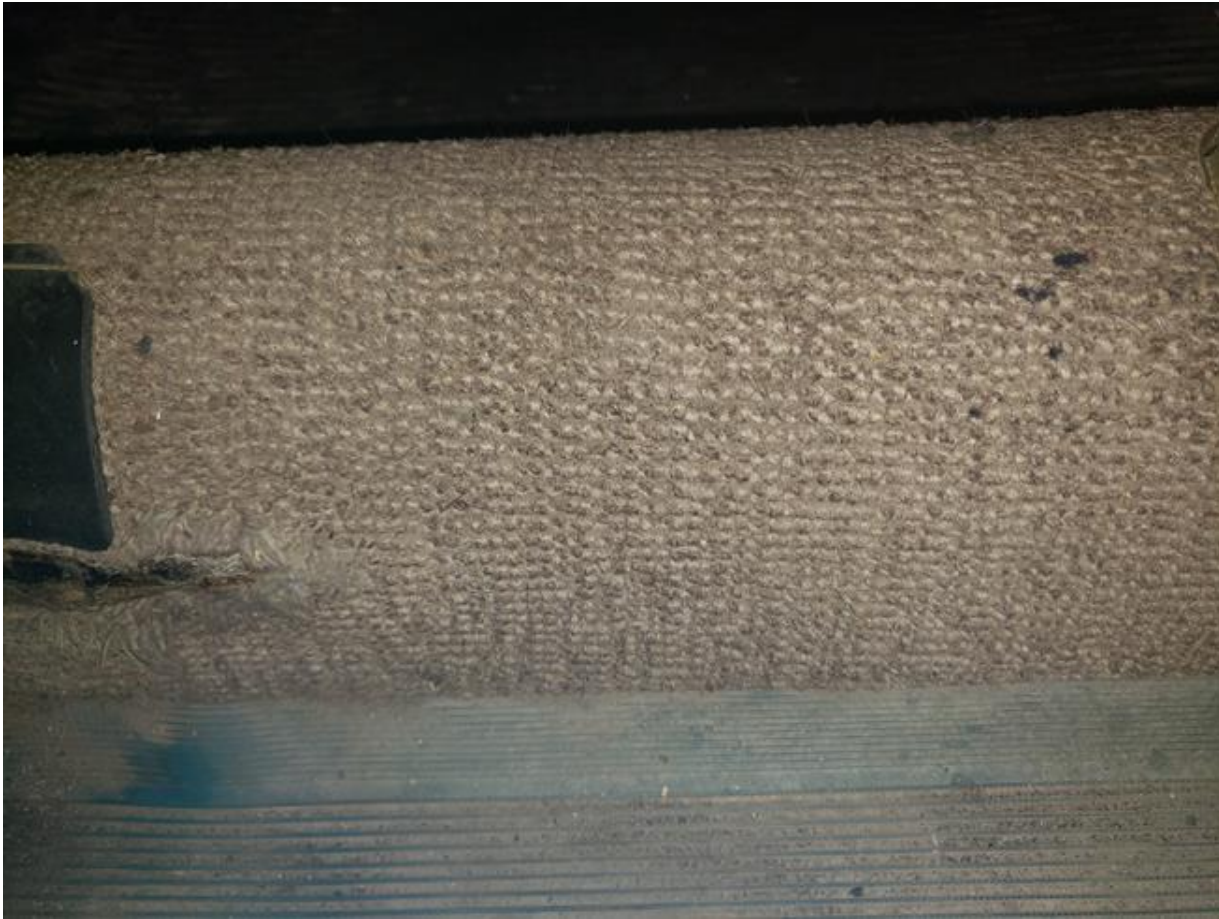
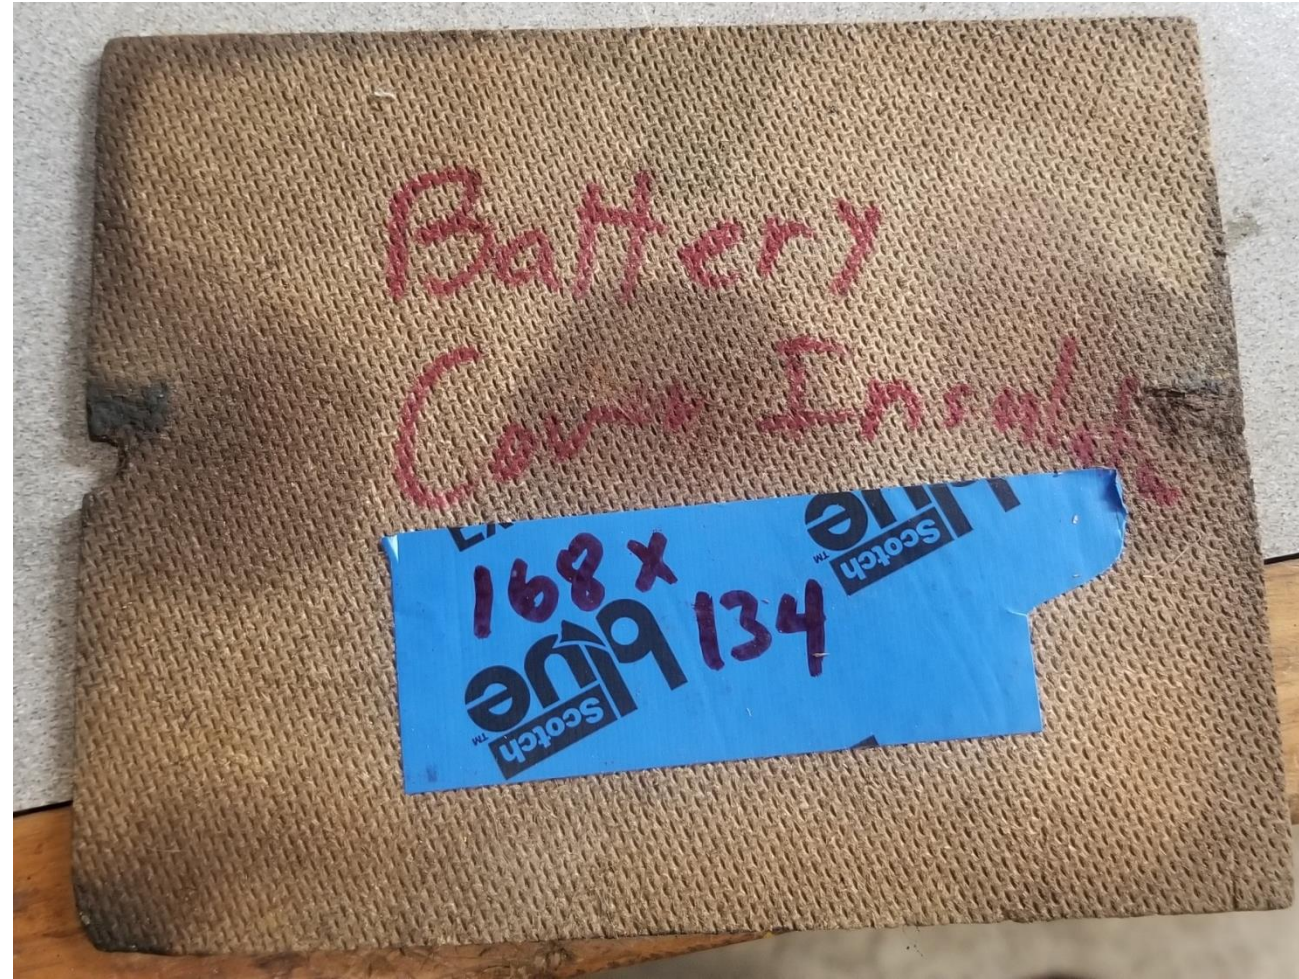
Same hardboard material as the door cards.
