Maintenance Service - Type 3

**Maintenance Service  
for Volkswagen 1500**

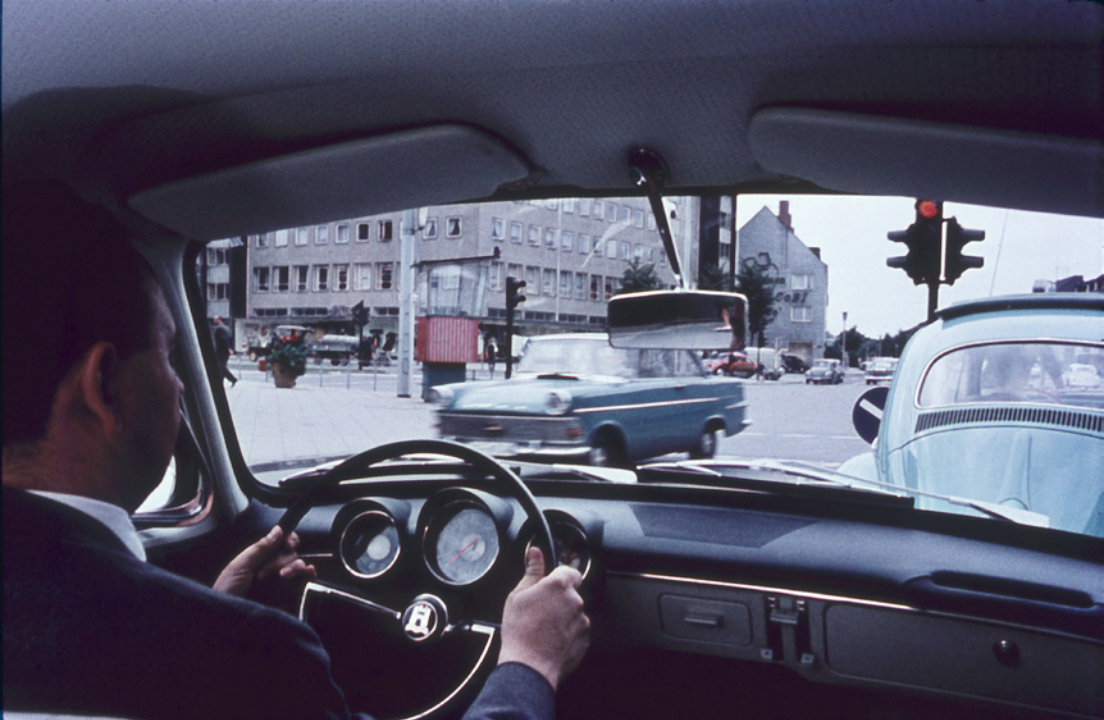
**18/1** – Cars now-a-days have acquired a noticeable degree of technical perfection and reliability. The best vehicle, however, still requires regular maintenance and care if its good basic construction and properties are to be retained. There is no such thing as a completely maintenance-free vehicle and for various reasons there will not be one for a long time to come. One of the most important reasons is to keep the vehicle road-safe.

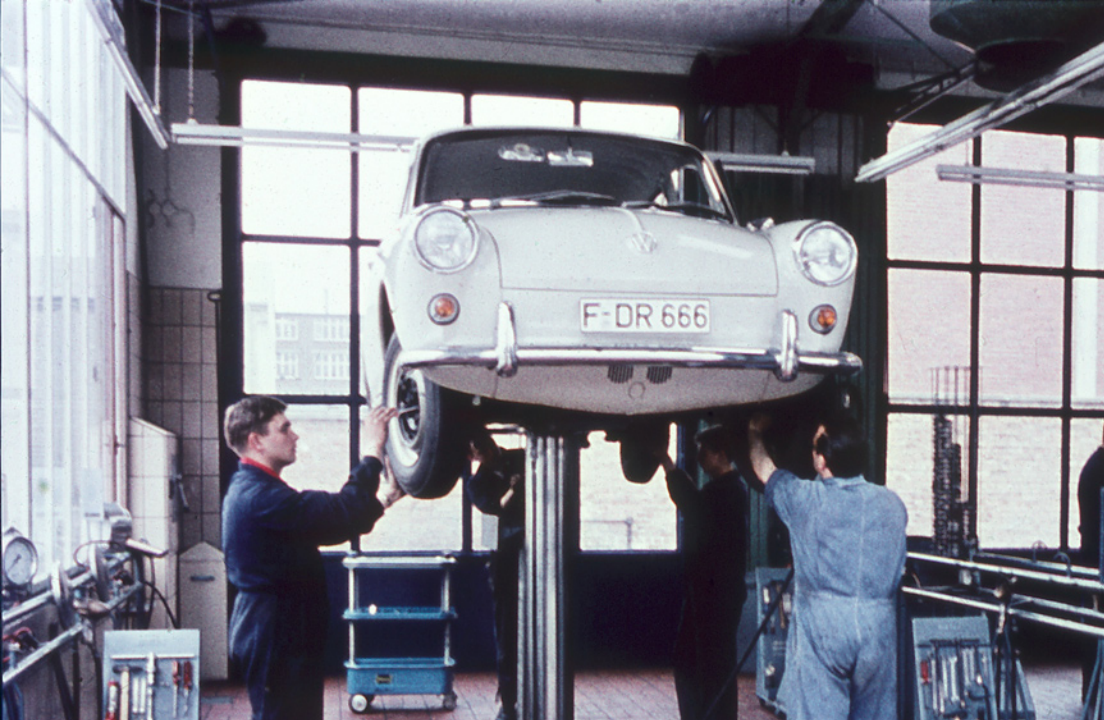
**18/2** – The proven 3000 mile maintenance interval is also applicable to the Type 3 – which is the internal designation of the Volkswagen 1500. If we compare the VW 1500's lubrication chart with that of the Type 1 – Volkswagen 1200, we notice that the lubrication service too is only carried out at the same 3000 mile intervals – the further developed front axle of the Type 3 with its ball joints which need little servicing does not require the in-between lubrication.

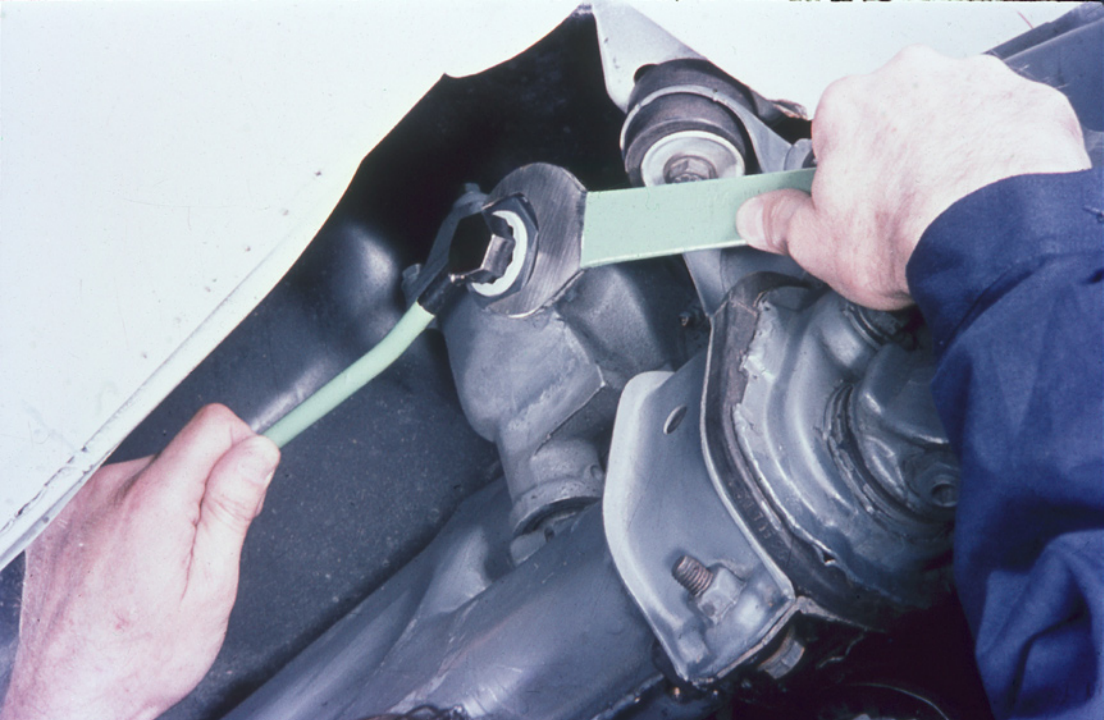
**18/5** – If the play is excessive, three points may be at fault:

a – the steering worm

b – the steering roller has play at the steering worm in the center position

c – the steering roller has excessive axial play.

We are only interested in points a and b because during the maintenance service we can only check and adjust these parts. Point c can only be checked when the steering gear is removed and the fault eliminated by replacing the steering roller shaft.

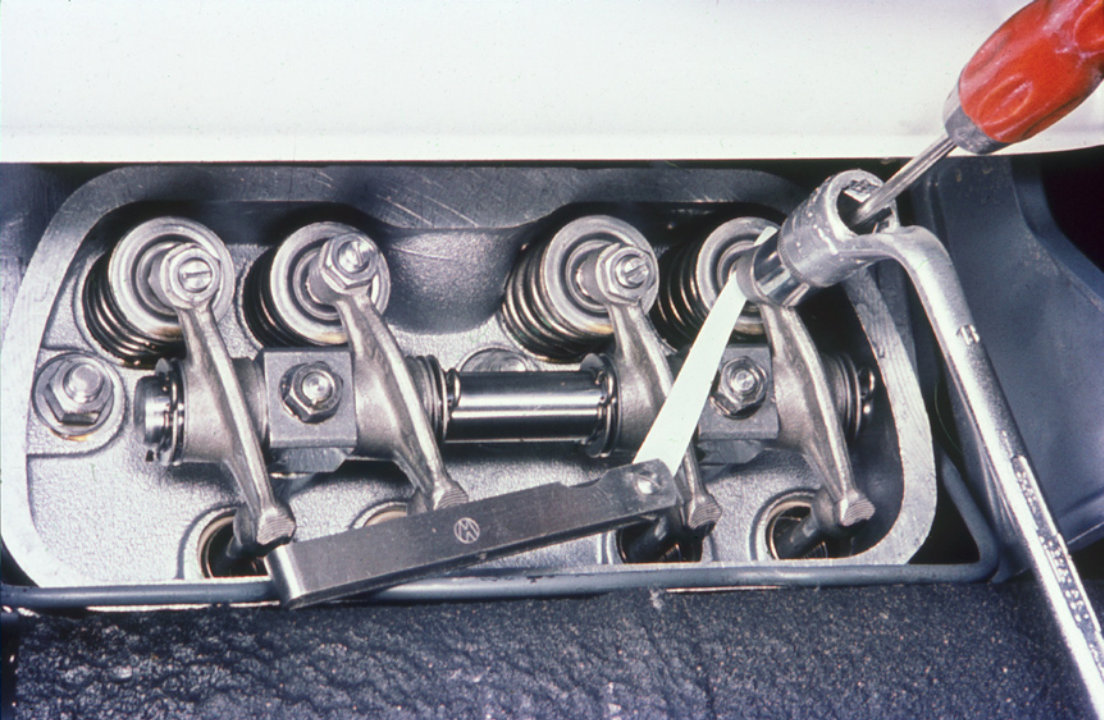
**18/32** – The engine must always be sufficiently cold before the ignition can be checked or set. The oil temperature in the crankcase must not exceed 50 °C (122 °F). When checking and adjusting the ignition timing we use a 6 volt test lamp and the adjustment gauge VW 660 which is mounted on the adjustment surface of the fan housing. The point of the gauge and the center of the timing mark on the crankshaft pulley must be in line. The engine must only be turned in a clockwise direction to take up the play in the distributor drive gear.

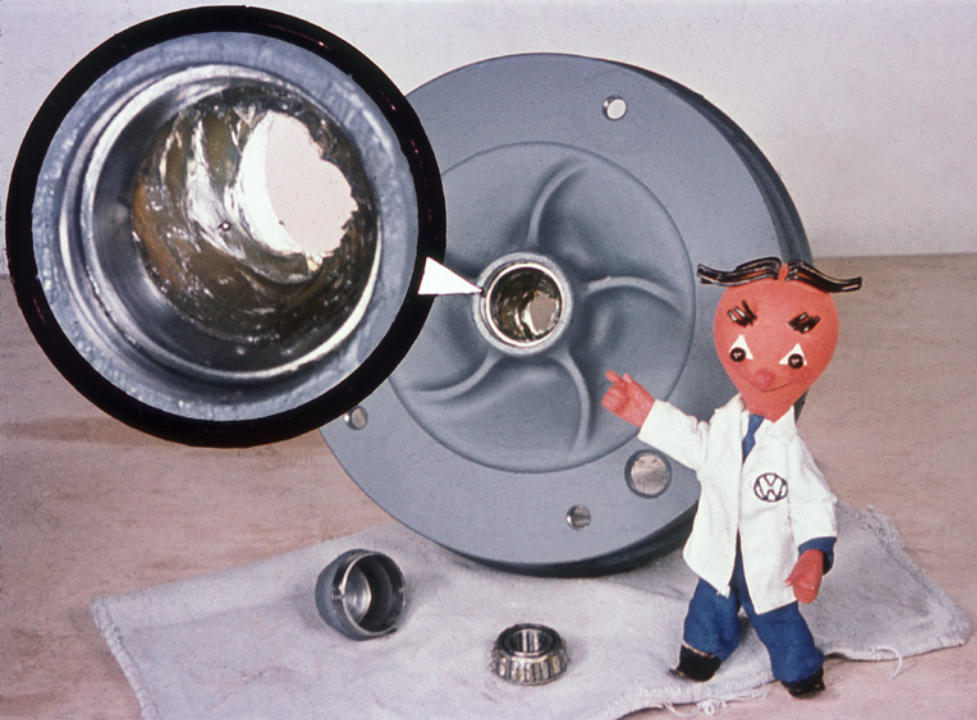
**18/36** – The front wheel bearing play is checked at the 300 mile maintenance service. If it is necessary to adjust the bearings we use a torque wrench.

First of all the inner bearing nut is tightened to 21 ft. lbs. This seats the bearings properly. Now slacken the nut until the thrust washer can just be moved with a screwdriver, hold the nut in this position and tighten the lock nut to 50 ft. lbs. Always use a new lock plate. This operation is shown here. The bearings are correctly adjusted if we can just move the thrust washer and the wheels moves freely in both directions without axial play.

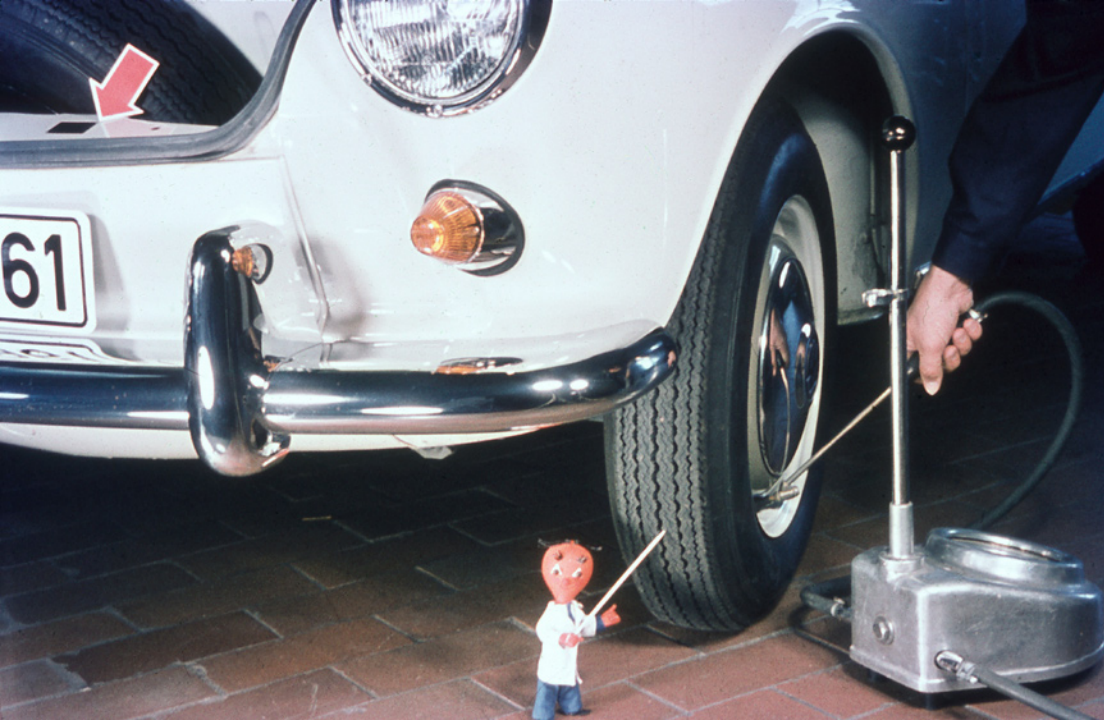
**18/37** – Before lubricating the front wheel bearings at 30,000 miles with grease as specified in the Maintenance Chart, the bearings and inner hubs are washed out carefully and the bearings checked for wear. The prescribed heat-resistant multi-purpose grease is packed between the cages and the rollers and the space between bearing seats is also filled with grease.

Why is it wrong to fill the complete hub with grease? Only a very thin layer of grease lubricates the roller bearings: superfluous grease must have space to expand into the hub.
