BODY LEAKS • VW SEDAN

Slide Series № 9

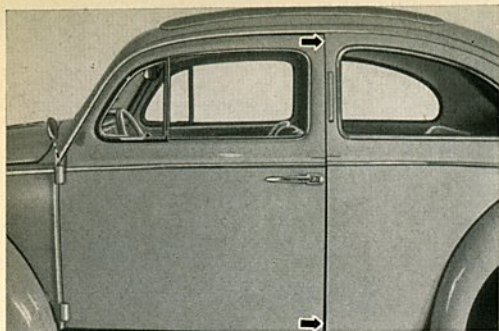
9/3 Inefficient servicing can often result in leaks and noises and it is often possible to eliminate two complaints of the same time. The first example: The arrow points towards the incorrect door gap. In the upper region the door nearly bears on the lock pillar whereas the gap shown by the lower arrow is too large.

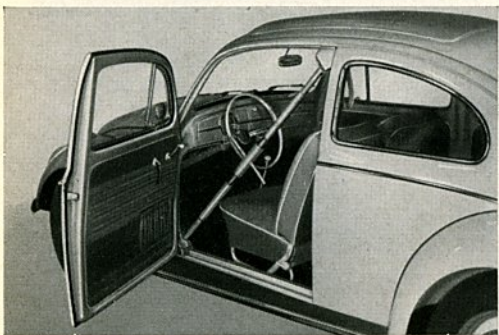
9/4 The striker plate has to be removed when commencing with door adjustments as otherwise the door fit cannot be correctly checked. The waistline shown here is very helpful. The better the door fits with the striker plate removed the less corrections will have to be made later when adjusting the striker plate. This fact also lengthens the life of the lock.

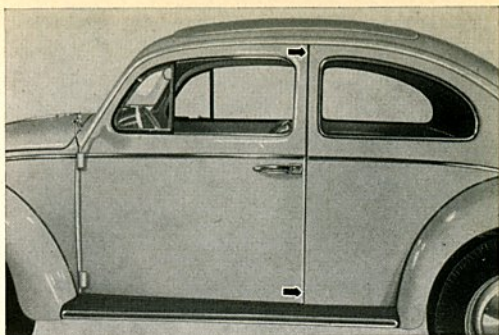
9/7 If the gap between door and lock pillar becomes wider towards the roof, it may be necessary in cases where the expander is of no avail, to raise the body at the rear.

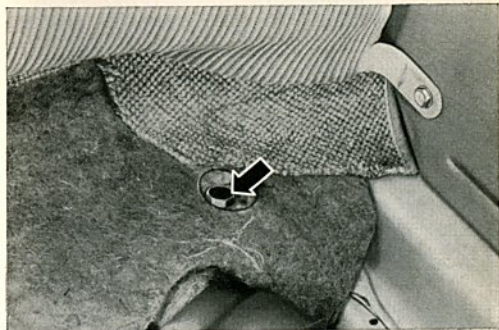
9/8 Two bolts have to be loosened for this purpose: This one under the rear seat.

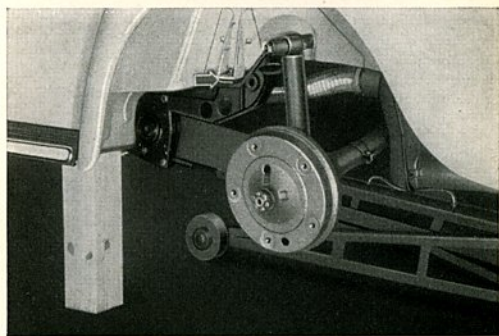
9/9 and this bolt which attaches the rear quarter panel to the chassis. Back off both bolts approximately 5 turns.

To loosen the bolt for the rear quarter panel support lift the vehicle at the rear and take off the wheel. Now lower the jack slowly and at the same time support the rear quarter panel with a wooden wedge. The arrow shows the location where the body should lift.

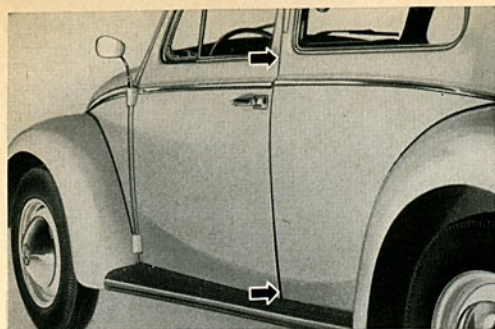
9/11 The ingress of water shown here would have been eliminated in an efficient workshop. It can be seen clearly that the door is protruding at the bottom whereas at the middle it is flush with the rear quarter panel.

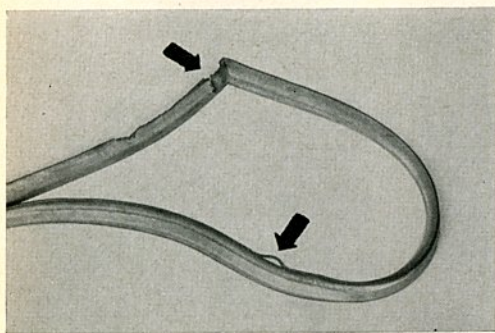
9/13 Another point. Incorrectly fitting doors usually cause damage to the door weatherstrip. It is generally necessary to replace this weatherstrip when carrying out adjustments of the door.

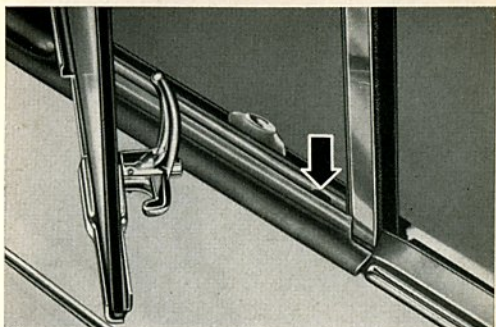
9/16 Make sure that the weatherstrip channel shown here is not blocked since the water which has entered flows along it to the drain holes in the bottom of the door.

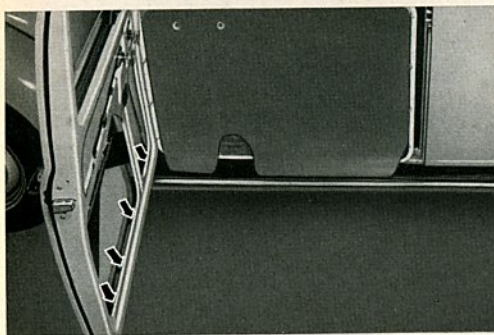
9/20 In this connection too, we stress the importance of the waterproof paper on the door trims and the drain holes in the door.

The window weatherstrip never seals completely.

The waterproof paper is intended to direct the water to the drain holes shown here by the arrows. If these holes become blocked, water will collect in the door.

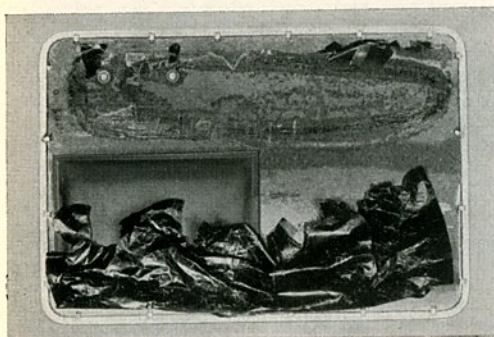
9/21 This has actually happened here. The waterproof paper has become loose and prevented the water from draining off.

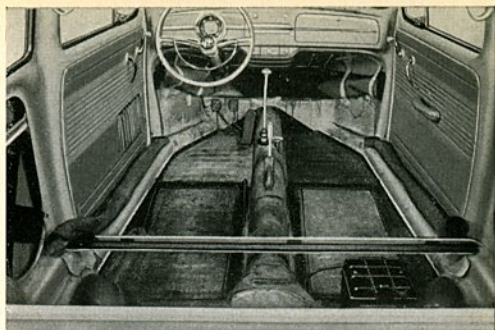
9/24 This also applies to the side member seams. Water which has seeped through the outer body skin often collects in the side member and leaks through at the locations shown here.

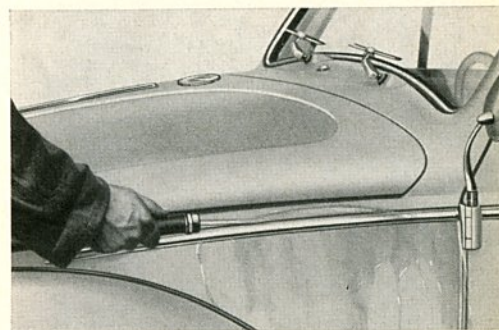
9/41 If leaks occur at the mouldings, the rubber caps are damaged. The arrow indicates a cap which has been cut by the sharp metal and now leaks.

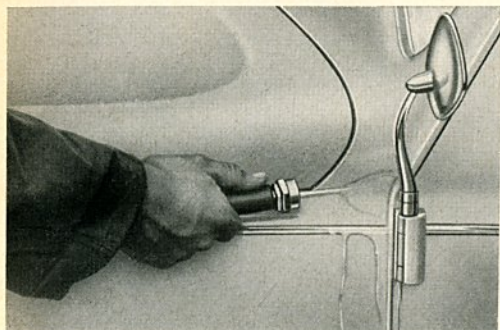
9/43 The seam at the joint between roof and front panel need only be sprayed, and sealed if necessary, on vehicles up to August 1959.

The vehicles are now brazed at this location during production to prevent an ingress of water.

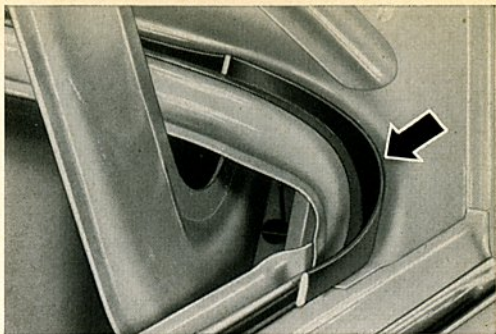
9/47 In this particular case the ingress of water was evident at the windshield. Leaks at the windshield can result in the water running down behind the instrument to the side members and then under the floor mats.
